Access Compliance Report Public Rights-of-Way (Curb Ramps)

Intersection ID: 6837 Main Street: ROUNDLEAF_DR Cross Street: SAWYER_DR Location: NE ADA ID: 51EE43BB3C08 Ramp Type: Perp Initial Pass/Fail: Fail Overall Compliance: No Severity Score: 40 Codes/Mitigation Info/Possible Solution Possible Solution: Possible Solutions: Remove & Replace Entire Ramp. N/A Ramp Length (in) 46.0 No Ramp Slope (%) 11.5 Yes Ramp Width (in) 67.0 No Ramp XSlope (%) 5.1 N/A Flare Type LT N/A Flare Type RT N/A N/A Flare Traversable LT? N/A Flare Traversable RT? N/A N/A Flare Traversable LT? N/A Flare Traversable RT? N/A
Codes/Mitigation Info/Possible Solution Field Measurements/Component Compliance Possible Solutions: Compliance Description Data Remove & Replace Entire Ramp. N/A Ramp Length (in) 46.0 No Ramp Slope (%) 11.5 Yea Ramp Width (in) 46.0 No Ramp Slope (%) 11.5
Possible Solutions: Compliance Description Data Compliance Description Data Remove & Replace Entire Ramp. N/A Ramp Length (in) 46.0 No Ramp Slope (%) 11.5 Yea Remove Width (in) 67.0 No Ramp XSlope (%) 51.4

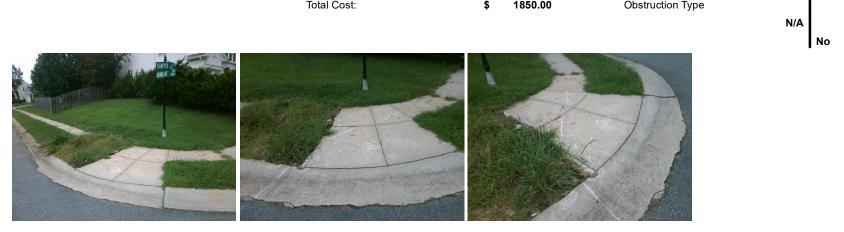
Possible Solutions: Compliance Description Data Compliance Description Data Remove & Replace Entire Ramp. N/A Ramp Length (in) 46.0 No Ramp Slope (%) 11.5 Yea Remove Width (in) 67.0 No Ramp XSlope (%) 51.4
N/A FIAIE TYPE LI N/A FIAIE TYPE RI N/A
N/A Flare Slope LT (%) N/A Flare Slope RT (%) N/A
N/A Flare Traversable LT? N/A N/A Flare Traversable RT? N/A
N/A Landing Length (in) N/A DWS Provided? N/A
Surveyor Notes: N/A Landing Width (in) N/A N/A DWS Contrast? N/A
N/A N/A DWS Length (in) N/A
N/A Landing X Slope (%) N/A DWS Full Width? N/A
N/A Landing Curb? (Y/N) N/A DWS Offset (in) N/A
N/A Shared Landing? N/A
PROW/ADA: N/A Gutter Ponding? N/A N/A Gutter Slope (%) N/A
Not Found, R304.2.2, R304.5.3, N/A Gutter Lip Ht (in) N/A Gutter X Slope (%) N/A
R302.7 N/A Painted X Walk1? No N/A Painted X Walk2? N/A
X Walk 1 Direction To NW X Walk 2 Direction N/A
N/A X Walk 1 Width (in) N/A X Walk 2 Width (in) N/A
Street 1 Name ROUNDLEAF DR X Walk 1 Slope (%) 2.3 X Walk 2 Slope (%) N/A

Stop Condition-Street 2 StopSign X Walk 1 X Slope (%) 5.3 X Walk 2 X Slope (%) N/A
Street 2 Name N/A N/A Ramp inside XWalk1? N/A N/A Ramp inside XWalk2? N/A
Stop Condition-Street 1 N/A N/A N/A Clear Space? N/A
Road X Slope (%) 2.3 N/A Clear Space to XWalk (in) N/A
N/A Any Obstructions? N/A N/A Storm Grate/Utility Hazard? N/A
Total Cost: \$ 1850.00 Obstruction Type Storm Grate/Utility Type
N/A N/A

Surface Condition? (G/P)

Poor
