Access Compliance Report

Public Rights-of-Way

(Curb Ramps)

Intersection ID: 4686	Main Street: EVANSHIRE_DR	Cross Street: TRINITY_RD	Location: NW
ADA ID: 51F364D30C38	Ramp Type: BlendTrans1	Initial Pass/Fail: Fail	Overall Compliance: No
Severity Score: 8.75			
Codes/Mitigation Info/Possible Solution		Field Measurements/Component Compliance

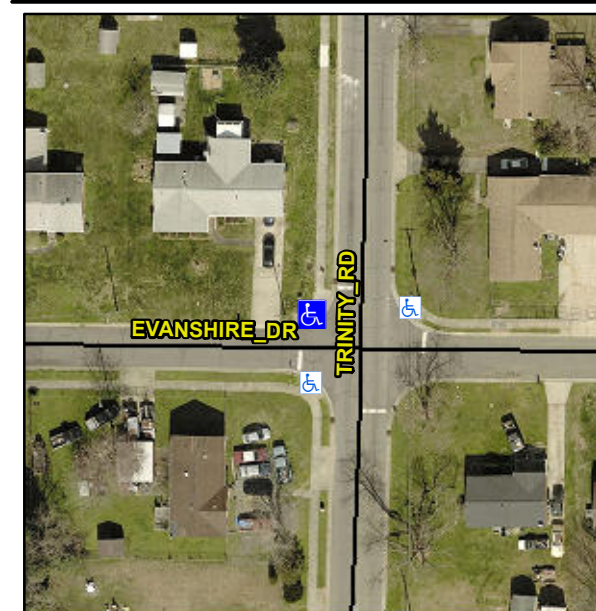
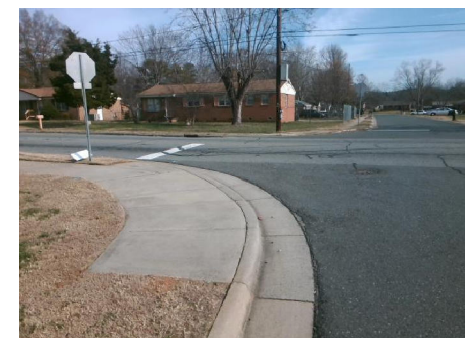
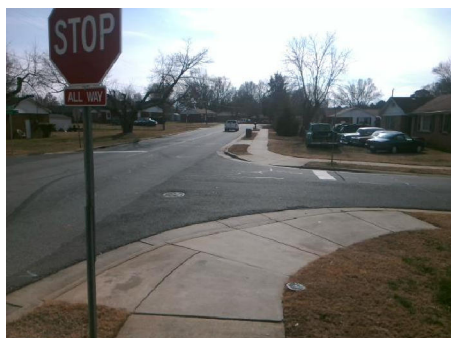
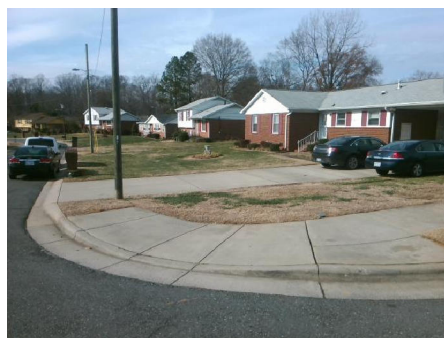
Compliance	Description	Data	Compliance	Description	Data
N/A	Ramp Length (in)	38.0	Yes	BlendTrans Slope (%)	3.1
No	Ramp Width (in)	37.0	Yes	BlendTrans XSlope (%)	2.0
N/A	Flare Type LT	N/A	N/A	Flare Type RT	N/A
N/A	Flare Slope LT (%)	N/A	N/A	Flare Slope RT (%)	N/A
N/A	Flare Traversable LT?	N/A	N/A	Flare Traversable RT?	N/A
N/A	Landing Length (in)	N/A	N/A	DWS Provided?	N/A
N/A	Landing Width (in)	N/A	N/A	DWS Contrast?	N/A
N/A	Landing Slope (%)	N/A	N/A	DWS Length (in)	N/A
N/A	Landing X Slope (%)	N/A	N/A	DWS Full Width?	N/A
N/A	Landing Curb? (Y/N)	N/A	N/A	DWS Offset (in)	N/A
N/A	Shared Landing?	N/A			
N/A	Gutter Ponding?	N/A	N/A	Gutter Slope (%)	N/A
N/A	Gutter Lip Ht (in)	1.0	N/A	Gutter X Slope (%)	N/A
N/A	Painted X Walk1?	No	N/A	Painted X Walk2?	No
	X Walk 1 Direction	To S		X Walk 2 Direction	To E
	X Walk 1 Width (in)	N/A		X Walk 2 Width (in)	N/A
	X Walk 1 Slope (%)	3.1		X Walk 2 Slope (%)	3.4
	X Walk 1 X Slope (%)	2.8		X Walk 2 X Slope (%)	0.3

N/A	Ramp inside XWalk1?	N/A	N/A	Ramp inside XWalk2?	N/A
	Road Slope (%)	3.6		Clear Space?	N/A
	Road X Slope (%)	3.9	N/A	Clear Space to XWalk (in)	N/A
N/A	Any Obstructions?	N/A	N/A	Storm Grate/Utility Hazard?	N/A
	Obstruction Type			Storm Grate/Utility Type	
		N/A			N/A
			Yes	Surface Condition? (G/P)	Good
			N/A	Curb Slope (%)	2.6

Possible Solutions:

Remove & Replace Curb Ramp With Two New Directional Ramps or Equivalent.

R304.5.1
