# Access Compliance Report

## Public Rights-of-Way

| Intersection ID: 17776 | Main Street: CHELSEA_DR | Cross Street: TRANQUIL_AV | Location: SE |
| ADA ID: 51FA7B335AE6 | Ramp Type: BlendTrans1 | Initial Pass/Fail: Pass | Overall Compliance: No |

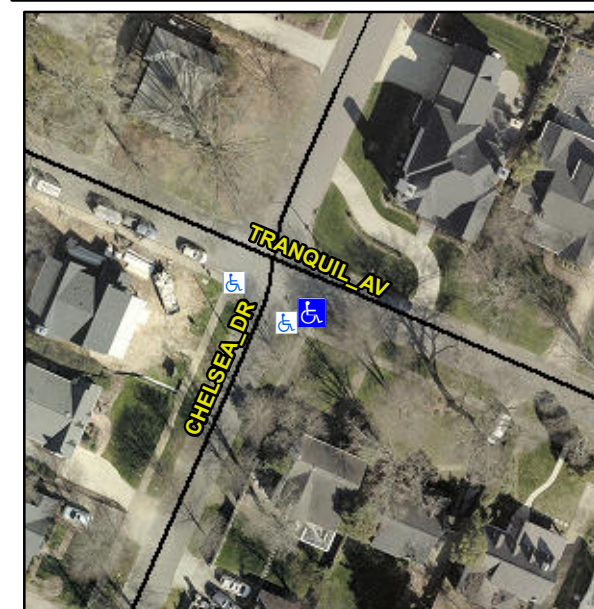
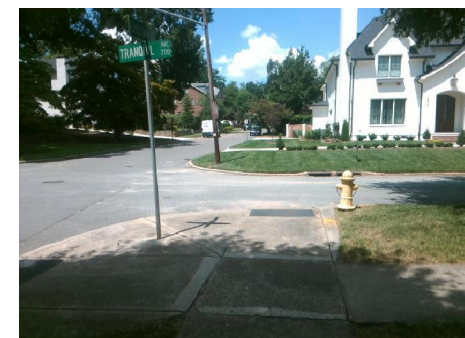
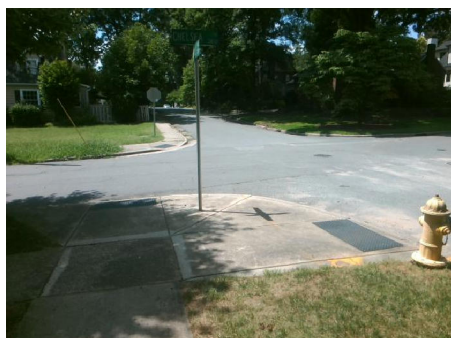
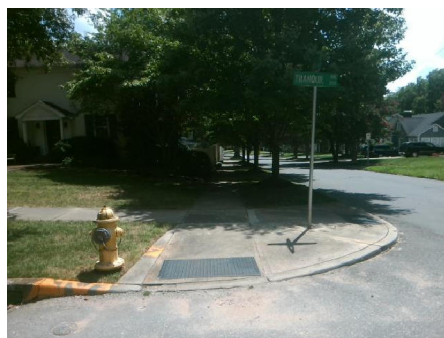
**RAMP LIP 1.5"**

**R305.1.4, R305.2, R302.7.2**

| Compliance | Description | Data | Compliance | Description | Data |
|---|---|---|---|---|---|
| Yes | Landing X Slope (%) | 0.5 | No | DWS Full Width? | No |
| N/A | Landing Curb? (Y/N) | No | No | DWS Offset (in) | 4.0 |
| No | Gutter Lip Ht (in) | 0.5 | Yes | Gutter X Slope (%) | 1.4 |

**Remove & Replace Detectable Warning System. Grind Gutter Lip.**
