Access Compliance Report

Public Rights-of-Way

(Curb Ramps)

Intersection ID: 19925	Main Street: SARDIS_RD	Cross Street: PROVIDENCE_RD	Location: NE
ADA ID: 51FEE5993931	Ramp Type: Perp	Initial Pass/Fail: Fail	Overall Compliance: No
Severity Score: 13.75			
Codes/Mitigation Info/Possible Solution		Field Measurements/Component Compliance

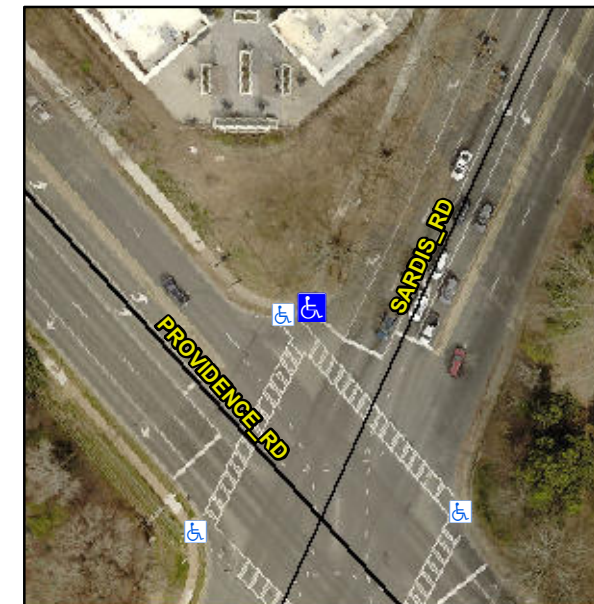
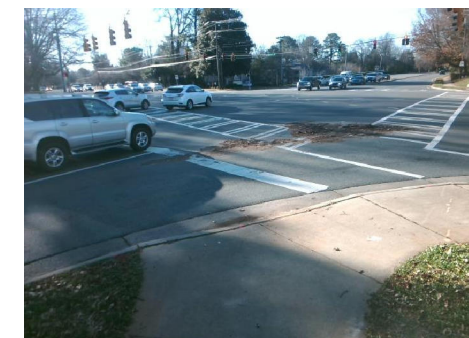
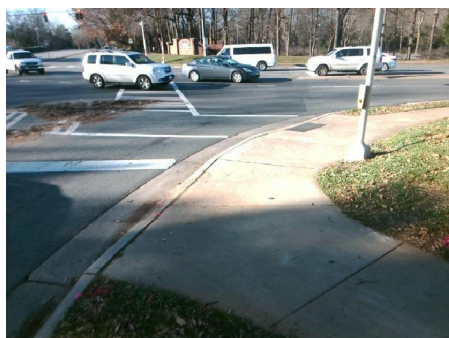
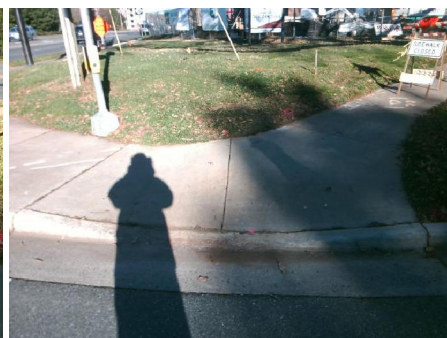
Not Found, R304.2.2, R304.5.3

Compliance	Description	Data	Compliance	Description	Data
N/A	Ramp Length (in)	48.0	No	Ramp Slope (%)	9.1
Yes	Ramp Width (in)	48.0	No	Ramp XSlope (%)	2.7
N/A	Flare Type LT	N/A	N/A	Flare Type RT	N/A
N/A	Flare Slope LT (%)	N/A	N/A	Flare Slope RT (%)	N/A
N/A	Flare Traversable LT?	N/A	N/A	Flare Traversable RT?	N/A
N/A	Landing Length (in)	N/A	N/A	DWS Provided?	N/A
N/A	Landing Width (in)	N/A	N/A	DWS Contrast?	N/A
N/A	Landing Slope (%)	N/A	N/A	DWS Length (in)	N/A
N/A	Landing X Slope (%)	N/A	N/A	DWS Full Width?	N/A
N/A	Landing Curb? (Y/N)	N/A	N/A	DWS Offset (in)	N/A
N/A	Shared Landing?	N/A			
N/A	Gutter Ponding?	N/A	N/A	Gutter Slope (%)	N/A
N/A	Gutter Lip Ht (in)	N/A	N/A	Gutter X Slope (%)	N/A
N/A	Painted X Walk1?	Yes	N/A	Painted X Walk2?	N/A
	X Walk 1 Direction	To SE		X Walk 2 Direction	N/A
N/A	X Walk 1 Width (in)	104.0	N/A	X Walk 2 Width (in)	N/A
	X Walk 1 Slope (%)	0.4		X Walk 2 Slope (%)	N/A
	X Walk 1 X Slope (%)	0.5		X Walk 2 X Slope (%)	N/A

N/A	Ramp inside XWalk1?	Yes	N/A	Ramp inside XWalk2?	N/A
	Road Slope (%)	N/A	N/A	Clear Space?	N/A
	Road X Slope (%)	N/A	N/A	Clear Space to XWalk (in)	N/A
N/A	Any Obstructions?	N/A	N/A	Storm Grate/Utility Hazard?	N/A
	Obstruction Type			Storm Grate/Utility Type	
		N/A			N/A
		Yes		Surface Condition? (G/P)	Good

Remove & Replace Entire Ramp.
