Access Compliance Report Public Rights-of-Way (Curb Ramps)

Intersection ID: 10034320	Main Street: PERIMETER_PY	Cross Street: N/A	Location: NW
ADA ID: 520015DE97DC	Ramp Type: Perp	Initial Pass/Fail: Fail	Overall Compliance: No Severity Score: 12.5

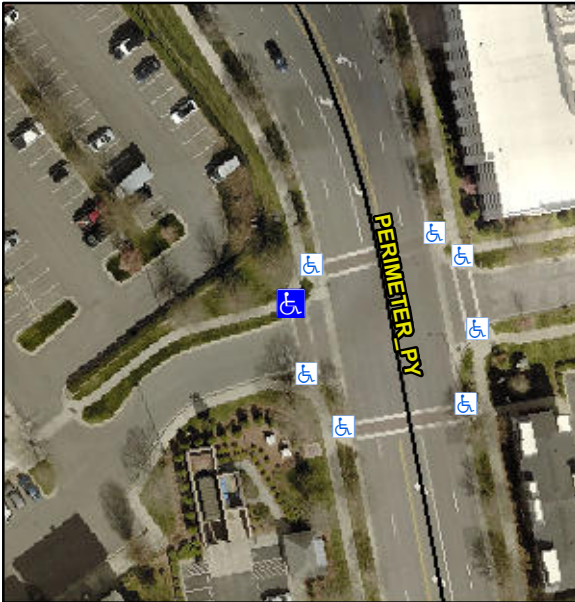
PROW/ADA:
Not Found, R304.2.2

Compliance	Description	Data	Compliance	Description	Data
N/A	Ramp Length (in)	49.0	No	Ramp Slope (%)	9.2
Yes	Ramp Width (in)	48.0	Yes	Ramp XSlope (%)	1.0
N/A	Flare Type LT	N/A	N/A	Flare Type RT	N/A
N/A	Flare Slope LT (%)	N/A	N/A	Flare Slope RT (%)	N/A
N/A	Flare Traversable LT?	N/A	N/A	Flare Traversable RT?	N/A
N/A	Landing Length (in)	N/A	N/A	DWS Provided?	N/A
N/A	Landing Width (in)	N/A	N/A	DWS Contrast?	N/A
N/A	Landing Slope (%)	N/A	N/A	DWS Length (in)	N/A
N/A	Landing X Slope (%)	N/A	N/A	DWS Full Width?	N/A
N/A	Landing Curb? (Y/N)	N/A	N/A	DWS Offset (in)	N/A
N/A	Shared Landing?	N/A			
N/A	Gutter Ponding?	N/A	N/A	Gutter Slope (%)	N/A
N/A	Gutter Lip Ht (in)	N/A	N/A	Gutter X Slope (%)	N/A
N/A	Painted X Walk1?	Yes	N/A	Painted X Walk2?	N/A
	X Walk 1 Direction	To S		X Walk 2 Direction	N/A
N/A	X Walk 1 Width (in)	72.0	N/A	X Walk 2 Width (in)	N/A
	X Walk 1 Slope (%)	4.1		X Walk 2 Slope (%)	N/A
	X Walk 1 X Slope (%)	1.2		X Walk 2 X Slope (%)	N/A

Possible Solutions:
Remove & Replace Entire Ramp.
