## Access Compliance Report Public Rights-of-Way (Curb Ramps)

Intersection ID: 50245 Main Street: HANBERRY\_BV Cross Street: PORTAFERRY\_DR Location: E

ADA ID: 5203204413C9 Ramp Type: Perp Initial Pass/Fail: Fail Overall Compliance: No Severity Score: 8.75

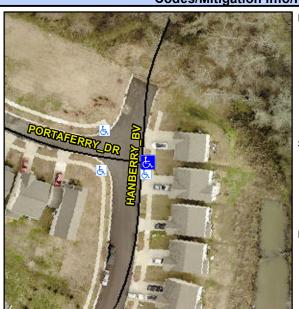
Field Measurements/Component Compliance								
Comp	liance Description	Data	Comp	liance Description	Data			
N/A	Ramp Length (in)	72.0	Yes	Ramp Slope (%)	5.8			
No	Ramp Width (in)	47.0	Yes	Ramp XSlope (%)	1.4			
N/A	Flare Type LT	N/A	N/A	Flare Type RT	N/A			
N/A	Flare Slope LT (%)	N/A	N/A	Flare Slope RT (%)	N/A			
N/A	Flare Traversable LT?	N/A	N/A	Flare Traversable RT?	N/A			
N/A	Landing Length (in)	N/A	N/A	DWS Provided?	N/A			
N/A	Landing Width (in)	N/A	N/A	DWS Contrast?	N/A			
N/A	Landing Slope (%)	N/A	N/A	DWS Length (in)	N/A			
N/A	Landing X Slope (%)	N/A	N/A	DWS Full Width?	N/A			
N/A	Landing Curb? (Y/N)	N/A	N/A	DWS Offset (in)	N/A			
N/A	Shared Landing?	N/A						
N/A	Gutter Ponding?	N/A	N/A	Gutter Slope (%)	N/A			
N/A	Gutter Lip Ht (in)	N/A	N/A	Gutter X Slope (%)	N/A			
N/A	Painted X Walk1?	No	N/A	Painted X Walk2?	N/A			
	X Walk 1 Direction	To W		X Walk 2 Direction	N/A			
N/A	X Walk 1 Width (in)	N/A	N/A	X Walk 2 Width (in)	N/A

X Walk 1 Slope (%)	4.8		X Walk 2 Slope (%)	N/A			
	X Walk 1 X Slope (%)	0.5		X Walk 2 X Slope (%)	N/A			
N/A	Ramp inside XWalk1?	N/A	N/A	Ramp inside XWalk2?	N/A			
	Road Slope (%)	N/A	N/A	Clear Space?	N/A			
	Road X Slope (%)	N/A	N/A	Clear Space to XWalk (in)	N/A			
N/A	Any Obstructions?	N/A	N/A	Storm Grate/Utility Hazard?	N/A			
	Obstruction Type			Storm Grate/Utility Type				
		N/A			N/A			
			Yes	Surface Condition? (G/P)	Good

Possible Solution	
Possible Solutions:	Con
Remove & Replace Entire Ramp.	N/A
	No
	N/A
	N/A
	N/A
	N/A
Surveyor Notes:	N/A
N/A	N/A
	N/A
	N/A
	N/A
PROW/ADA:	N/A
Not Found, R304.5.1	N/A
	N/A
	N/A
	N/A
