Access Compliance Report

Public Rights-of-Way

(Curb Ramps)

Intersection ID: 30137	Main Street: DIETRICH_LN	Cross Street: RUMPLE_RD	Location: W
ADA ID: 520D93DB32BD	Ramp Type: PerpDiag	Initial Pass/Fail: Fail	Overall Compliance: No
Severity Score: 10			
Codes/Mitigation Info/Possible Solution		Field Measurements/Component Compliance

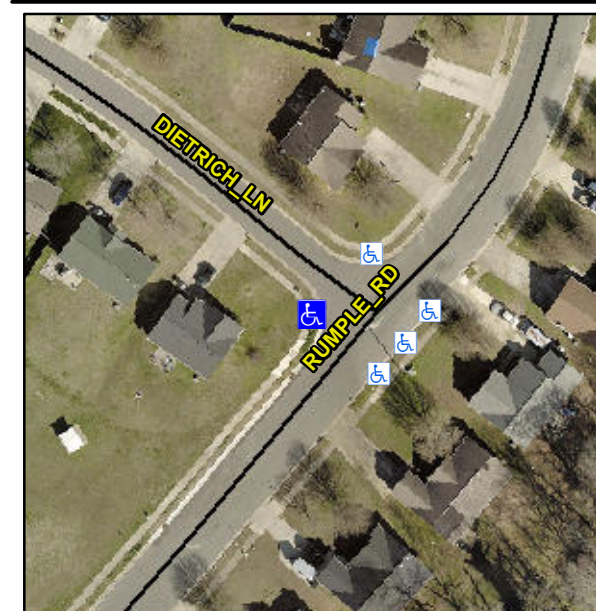
Not Found, R304.5.1, R304.5.3

Compliance	Description	Data	Compliance	Description	Data
N/A	Ramp Length (in)	50.0	Yes	Ramp Slope (%)	8.2
No	Ramp Width (in)	41.0	No	Ramp XSlope (%)	3.6
N/A	Flare Type LT	N/A	N/A	Flare Type RT	N/A
N/A	Flare Slope LT (%)	N/A	N/A	Flare Slope RT (%)	N/A
N/A	Flare Traversable LT?	N/A	N/A	Flare Traversable RT?	N/A
N/A	Landing Length (in)	N/A	N/A	DWS Provided?	N/A
N/A	Landing Width (in)	N/A	N/A	DWS Contrast?	N/A
N/A	Landing Slope (%)	N/A	N/A	DWS Length (in)	N/A
N/A	Landing X Slope (%)	N/A	N/A	DWS Full Width?	N/A
N/A	Landing Curb? (Y/N)	N/A	N/A	DWS Offset (in)	N/A
N/A	Shared Landing?	N/A			
N/A	Gutter Ponding?	N/A	N/A	Gutter Slope (%)	N/A
N/A	Gutter Lip Ht (in)	N/A	N/A	Gutter X Slope (%)	N/A
N/A	Painted X Walk1?	No	N/A	Painted X Walk2?	No
	X Walk 1 Direction	To SE		X Walk 2 Direction	To NE
N/A	X Walk 1 Width (in)	N/A	N/A	X Walk 2 Width (in)	N/A
	X Walk 1 Slope (%)	4.9		X Walk 2 Slope (%)	3.0
	X Walk 1 X Slope (%)	3.1		X Walk 2 X Slope (%)	4.1

N/A	Ramp inside XWalk1?	N/A	N/A	Ramp inside XWalk2?	N/A
	Road Slope (%)	2.4	N/A	Clear Space?	N/A
	Road X Slope (%)	6.2	N/A	Clear Space to XWalk (in)	N/A
N/A	Any Obstructions?	N/A	N/A	Storm Grate/Utility Hazard?	N/A
	Obstruction Type			Storm Grate/Utility Type	
		N/A			N/A
			Yes	Surface Condition? (G/P)	Good

Remove & Replace Curb Ramp With Two New Directional Ramps or Equivalent.

Total Cost: \$ 3200.00
