Access Compliance Report

Public Rights-of-Way

(Curb Ramps)

Intersection ID: 10022558	Main Street: CARMEL_COMMONS_BV	Cross Street: N/A	Location: NW
ADA ID: 5213032456BB	Ramp Type: PerpDiag	Initial Pass/Fail: Fail	Overall Compliance: No
Severity Score: 36.25			
Codes/Mitigation Info/Possible Solution		Field Measurements/Component Compliance

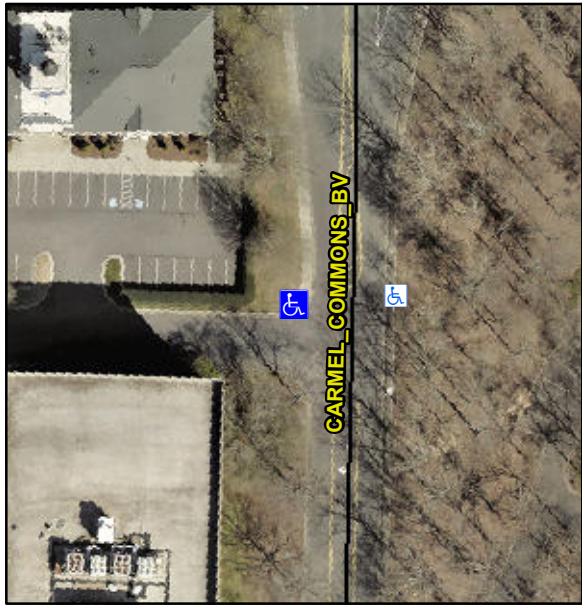
Possible Solutions:		Compliance		Description		Data	Compliance		Description		Data
	Remove & Replace Curb Ramp With Two New Directional Ramps or Equivalent.		N/A	Ramp Length (in)	73.5	Yes	Ramp Slope (%)	7.1				
			No	Ramp Width (in)	31.0	No	Ramp XSlope (%)	2.4				
			N/A	Flare Type LT	N/A	N/A	Flare Type RT	N/A				
			N/A	Flare Slope LT (%)	N/A	N/A	Flare Slope RT (%)	N/A				
			N/A	Flare Traversable LT?	N/A	N/A	Flare Traversable RT?	N/A				
			N/A	Landing Length (in)	N/A	N/A	DWS Provided?	N/A				
			N/A	Landing Width (in)	N/A	N/A	DWS Contrast?	N/A				
			N/A	Landing Slope (%)	N/A	N/A	DWS Length (in)	N/A				
			N/A	Landing X Slope (%)	N/A	N/A	DWS Full Width?	N/A				
Surveyor Notes:		N/A	N/A	Landing Curb? (Y/N)	N/A	N/A	DWS Offset (in)	N/A				
			N/A	Shared Landing?	N/A							
PROW/ADA:			N/A	Gutter Ponding?	N/A	N/A	Gutter Slope (%)	N/A				
			N/A	Gutter Lip Ht (in)	N/A	N/A	Gutter X Slope (%)	N/A				
			N/A	Painted X Walk1?	No	N/A	Painted X Walk2?	No

X Walk 1 Direction	To S		X Walk 2 Direction	To E				
			N/A	X Walk 1 Width (in)	N/A	N/A	X Walk 2 Width (in)	N/A				
				X Walk 1 Slope (%)	3.5		X Walk 2 Slope (%)	1.5				
				X Walk 1 X Slope (%)	5.0		X Walk 2 X Slope (%)	0.3				
			N/A	Ramp inside XWalk1?	N/A	N/A	Ramp inside XWalk2?	N/A				
				Road Slope (%)	1.6	N/A	Clear Space?	N/A				
				Road X Slope (%)	1.8	N/A	Clear Space to XWalk (in)	N/A				
			N/A	Any Obstructions?	N/A	N/A	Storm Grate/Utility Hazard?	N/A				
				Obstruction Type			Storm Grate/Utility Type					
						N/A						N/A
							Yes	Surface Condition? (G/P)	Good
