Access Compliance Report

Public Rights-of-Way

(Curb Ramps)

| Intersection ID: 28061 | Main Street: CORRYSTONE_DR | Cross Street: WILLOW_ROCK_DR | Location: S |

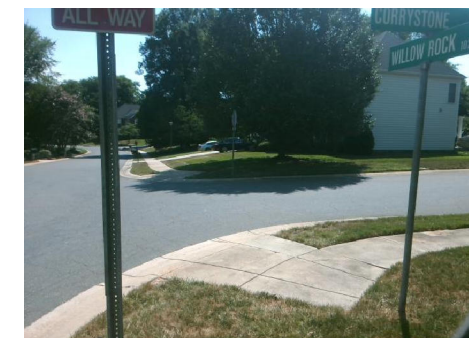
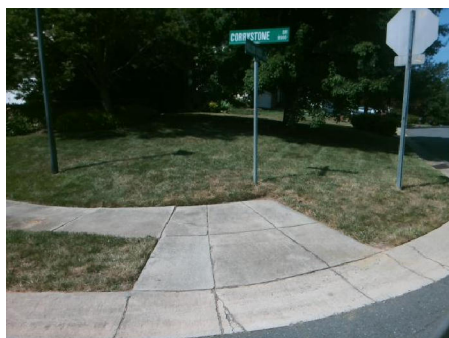
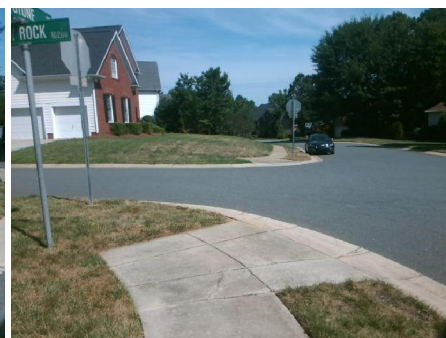
| ADA ID: 5218AE7099EE | Ramp Type: PerpDiag | Initial Pass/Fail: Fail | Overall Compliance: No |
| | | Severity Score: 42.5 | |

Not Found, R304.5.1, R304.2.2, R304.5.3

| Compliance | Description | Data | Compliance | Description | Data |
|---|---|---|---|---|---|
| N/A | Ramp Length (in) | 46.0 | No | Ramp Slope (%) | 10.3 |
| No | Ramp Width (in) | 35.0 | No | Ramp XSlope (%) | 6.8 |

Remove & Replace Curb Ramp With Two New Directional Ramps or Equivalent.
