# Access Compliance Report

## Public Rights-of-Way

### (Curb Ramps)

Intersection ID: 3220	Main Street: MEADOW_POST_LN	Cross Street: OLD_TIMBER_RD	Location: NW
ADA ID: 52232AFBFCD3	Ramp Type: BlendTrans1	Initial Pass/Fail: Fail	Overall Compliance: No
		Severity Score: 1.25

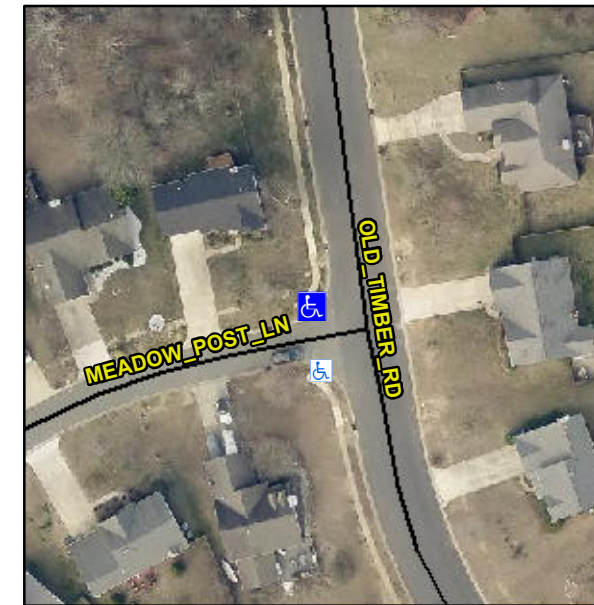
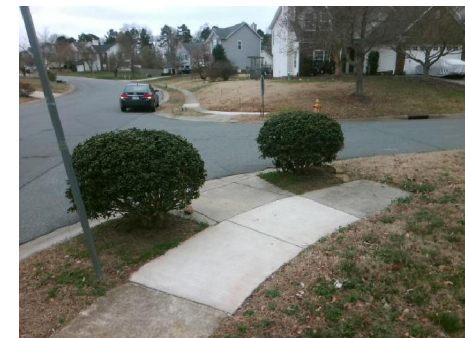
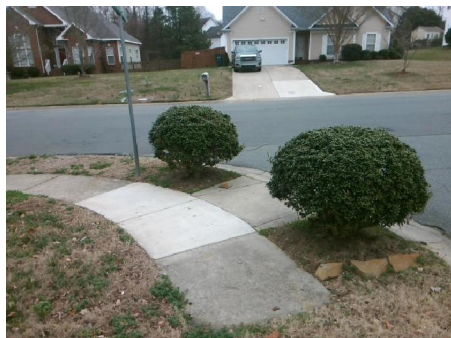
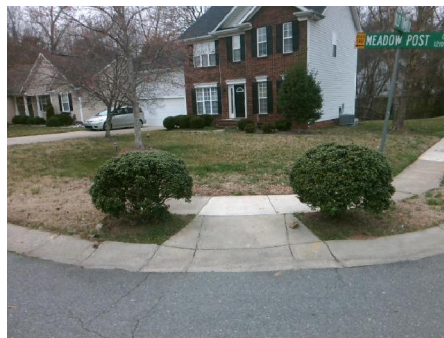
**Not Found, R304.5.3**

Compliance	Description	Data	Compliance	Description	Data
N/A	Ramp Length (in)	49.0	Yes	BlendTrans Slope (%)	3.2
Yes	Ramp Width (in)	49.0	No	BlendTrans XSlope (%)	3.0
N/A	Flare Type LT	N/A	N/A	Flare Type RT	N/A
N/A	Flare Slope LT (%)	N/A	N/A	Flare Slope RT (%)	N/A
N/A	Flare Traversable LT?	N/A	N/A	Flare Traversable RT?	N/A
N/A	Landing Length (in)	N/A	N/A	DWS Provided?	N/A
N/A	Landing Width (in)	N/A	N/A	DWS Contrast?	N/A
N/A	Landing Slope (%)	N/A	N/A	DWS Length (in)	N/A
N/A	Landing X Slope (%)	N/A	N/A	DWS Full Width?	N/A
N/A	Landing Curb? (Y/N)	N/A	N/A	DWS Offset (in)	N/A
N/A	Shared Landing?	N/A			
N/A	Gutter Ponding?	N/A	N/A	Gutter Slope (%)	N/A
N/A	Gutter Lip Ht (in)	N/A	N/A	Gutter X Slope (%)	N/A
N/A	Painted X Walk1?	No	N/A	Painted X Walk2?	N/A
	X Walk 1 Direction	To S		X Walk 2 Direction	N/A
	X Walk 1 Width (in)	N/A		X Walk 2 Width (in)	N/A
	X Walk 1 Slope (%)	4.3		X Walk 2 Slope (%)	N/A
	X Walk 1 X Slope (%)	0.3		X Walk 2 X Slope (%)	N/A

N/A	Ramp inside XWalk1?	N/A	N/A	Ramp inside XWalk2?	N/A
	Road Slope (%)	0.3		Clear Space?	N/A
	Road X Slope (%)	4.3	N/A	Clear Space to XWalk (in)	N/A
N/A	Any Obstructions?	N/A	N/A	Storm Grate/Utility Hazard?	N/A
	Obstruction Type			Storm Grate/Utility Type	
		N/A			N/A
			Yes	Surface Condition? (G/P)	Good
			No	Curb Slope (%)	20.3

**Remove & Replace Curb Ramp With Two New Directional Ramps or Equivalent.**
