## **Access Compliance Report Public Rights-of-Way** (Curb Ramps)

Main Street: WHITEHALL EXECUTIVE CENTERS SDStreet: N/A Location: Intersection ID: 10041624 NW ADA ID: 5226C12A9C8C Ramp Type: PerpDiag Initial Pass/Fail: Fail **Overall Compliance: No** 35 **Severity Score:**

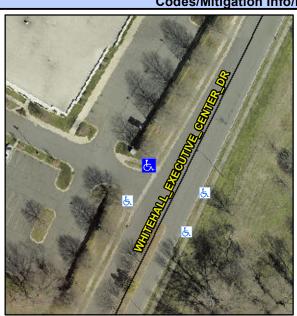
Not Found, R304.5.1

No	Ramp Width (in)	27.0	Yes	Ramp XSlope (%)
N/A	Flare Type LT	N/A	N/A	Flare Type RT
N/A	Flare Slope LT (%)	N/A	N/A	Flare Slope RT (%)
N/A	Flare Traversable LT?	N/A	N/A	Flare Traversable RT?
N/A	Landing Length (in)	N/A	N/A	DWS Provided?
N/A	Landing Width (in)	N/A	N/A	DWS Contrast?
N/A	Landing Slope (%)	N/A	N/A	DWS Length (in)
N/A	Landing X Slope (%)	N/A	N/A	DWS Full Width?
N/A	Landing Curb? (Y/N)	N/A	N/A	DWS Offset (in)
N/A	Shared Landing?	N/A		
N/A	Gutter Ponding?	N/A	N/A	Gutter Slope (%)
N/A	Gutter Lip Ht (in)	N/A	N/A	Gutter X Slope (%)
N/A	Painted X Walk1?	No	N/A	Painted X Walk2?
	X Walk 1 Direction	To SW		X Walk 2 Direction
N/A	X Walk 1 Width (in)	N/A	N/A	X Walk 2 Width (in)
	X Walk 1 Slope (%)	3.4		X Walk 2 Slope (%)
	X Walk 1 X Slope (%)	4.8		X Walk 2 X Slope (%)
N/A	Ramp inside XWalk1?	N/A	N/A	Ramp inside XWalk2?
	Road Slope (%)	2.9	N/A	Clear Space?
	Road X Slope (%)	6.5	N/A	Clear Space to XWalk (in)
N/A	Any Obstructions?	N/A	N/A	Storm Grate/Utility Hazard?

**ENTRANCE** Street 1 Name Stop Condition-Street 2 StopSign Street 2 Name ALL EXECUTIVE CENTER DR Remove & Replace Curb Ramp With Two New Directional Ramps or Equivalent.
