# Access Compliance Report

## Public Rights-of-Way

### (Curb Ramps)

Intersection ID: N/A	Main Street: WAVERLY_WALK_AV	Cross Street: HONEYMEADE_CIR	Location: NW
ADA ID: 5228D4119EDB	Ramp Type: Perp	Initial Pass/Fail: Fail	Overall Compliance: No
Severity Score: 1.25			
Codes/Mitigation Info/Possible Solution		Field Measurements/Component Compliance

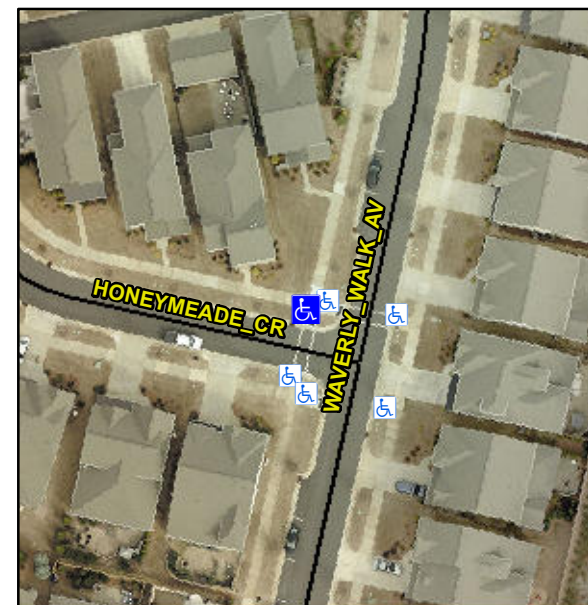
Compliance	Description	Data	Compliance	Description	Data
N/A	Ramp Length (in)	97.0	Yes	Ramp Slope (%)	8.3
Yes	Ramp Width (in)	72.0	No	Ramp XSlope (%)	2.9
N/A	Flare Type LT	N/A	N/A	Flare Type RT	N/A
N/A	Flare Slope LT (%)	N/A	N/A	Flare Slope RT (%)	N/A
N/A	Flare Traversable LT?	N/A	N/A	Flare Traversable RT?	N/A
N/A	Landing Length (in)	N/A	N/A	DWS Provided?	N/A
N/A	Landing Width (in)	N/A	N/A	DWS Contrast?	N/A
N/A	Landing Slope (%)	N/A	N/A	DWS Length (in)	N/A
N/A	Landing X Slope (%)	N/A	N/A	DWS Full Width?	N/A
N/A	Landing Curb? (Y/N)	N/A	N/A	DWS Offset (in)	N/A
N/A	Shared Landing?	N/A			
N/A	Gutter Ponding?	N/A	N/A	Gutter Slope (%)	N/A
N/A	Gutter Lip Ht (in)	N/A	N/A	Gutter X Slope (%)	N/A
N/A	Painted X Walk1?	No	N/A	Painted X Walk2?	N/A
	X Walk 1 Direction	To SW		X Walk 2 Direction	N/A
N/A	X Walk 1 Width (in)	N/A	N/A	X Walk 2 Width (in)	N/A
	X Walk 1 Slope (%)	0.7		X Walk 2 Slope (%)	N/A
	X Walk 1 X Slope (%)	1.4		X Walk 2 X Slope (%)	N/A

N/A	Ramp inside XWalk1?	N/A	N/A	Ramp inside XWalk2?	N/A
	Road Slope (%)	N/A	N/A	Clear Space?	N/A
	Road X Slope (%)	N/A	N/A	Clear Space to XWalk (in)	N/A
N/A	Any Obstructions?	N/A	N/A	Storm Grate/Utility Hazard?	N/A
	Obstruction Type			Storm Grate/Utility Type	
		N/A			N/A
		Yes		Surface Condition? (G/P)	Good

**Remove & Replace Entire Ramp.**

Total Cost: \$ **1850.00**
