Access Compliance Report

Public Rights-of-Way

(Curb Ramps)

Intersection ID: N/A	Main Street: MONROE_RD	Cross Street: FANNIE_CR	Location: SE
ADA ID: 522A823BE170	Ramp Type: PerpDiag	Initial Pass/Fail: Fail	Overall Compliance: No
Severity Score: 22.5			
Codes/Mitigation Info/Possible Solution		Field Measurements/Component Compliance

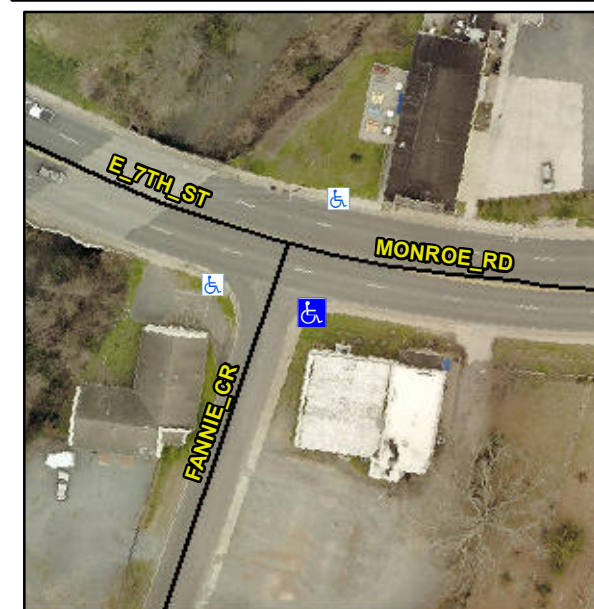
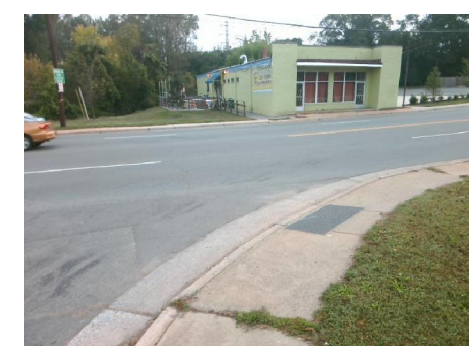
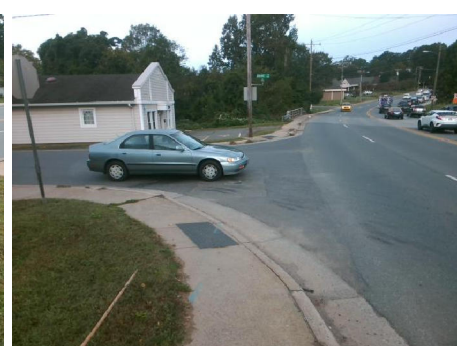
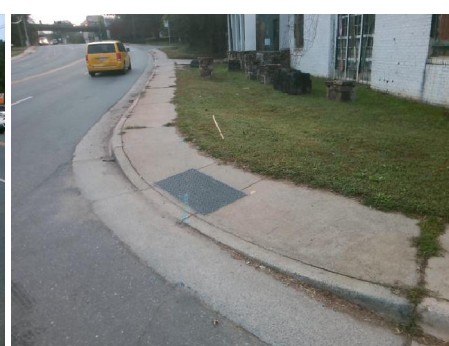
Not Found, R304.5.1, R304.2.2, R304.5.3

Compliance	Description	Data	Compliance	Description	Data
N/A	Ramp Length (in)	45.0	No	Ramp Slope (%)	10.7
No	Ramp Width (in)	37.0	No	Ramp XSlope (%)	2.4
N/A	Flare Type LT	N/A	N/A	Flare Type RT	N/A
N/A	Flare Slope LT (%)	N/A	N/A	Flare Slope RT (%)	N/A
N/A	Flare Traversable LT?	N/A	N/A	Flare Traversable RT?	N/A
N/A	Landing Length (in)	N/A	N/A	DWS Provided?	N/A
N/A	Landing Width (in)	N/A	N/A	DWS Contrast?	N/A
N/A	Landing Slope (%)	N/A	N/A	DWS Length (in)	N/A
N/A	Landing X Slope (%)	N/A	N/A	DWS Full Width?	N/A
N/A	Landing Curb? (Y/N)	N/A	N/A	DWS Offset (in)	N/A
N/A	Shared Landing?	N/A			
N/A	Gutter Ponding?	N/A	N/A	Gutter Slope (%)	N/A
N/A	Gutter Lip Ht (in)	N/A	N/A	Gutter X Slope (%)	N/A
N/A	Painted X Walk1?	No	N/A	Painted X Walk2?	No
	X Walk 1 Direction	To NE		X Walk 2 Direction	To NW
N/A	X Walk 1 Width (in)	N/A	N/A	X Walk 2 Width (in)	N/A
	X Walk 1 Slope (%)	1.5		X Walk 2 Slope (%)	2.7
	X Walk 1 X Slope (%)	2.2		X Walk 2 X Slope (%)	0.3

N/A	Ramp inside XWalk1?	N/A	N/A	Ramp inside XWalk2?	N/A
	Road Slope (%)	2.4	N/A	Clear Space?	N/A
	Road X Slope (%)	0.2	N/A	Clear Space to XWalk (in)	N/A
N/A	Any Obstructions?	N/A	N/A	Storm Grate/Utility Hazard?	N/A
	Obstruction Type			Storm Grate/Utility Type	
		N/A			N/A
			Yes	Surface Condition? (G/P)	Good

Remove & Replace Curb Ramp With Two New Directional Ramps or Equivalent.
