## Access Compliance Report Public Rights-of-Way (Curb Ramps)

Intersection ID: 12013 Main Street: FREEDOM\_DR Cross Street: W\_MOREHEAD\_ST Location: S

ADA ID: 523405A896C0 Ramp Type: Perp Initial Pass/Fail: Fail Overall Compliance: No Severity Score: 22.5

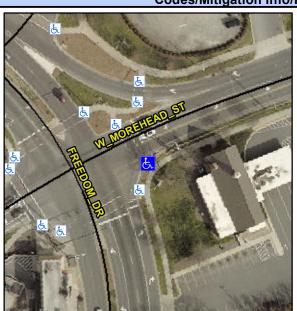
Field Measurements/Component Compliance								
Compl	iance Description	Data	Comp	liance Description	Data			
N/A	Ramp Length (in)	79.0	No	Ramp Slope (%)	8.4			
No	Ramp Width (in)	47.0	No	Ramp XSlope (%)	4.8			
N/A	Flare Type LT	N/A	N/A	Flare Type RT	N/A			
N/A	Flare Slope LT (%)	N/A	N/A	Flare Slope RT (%)	N/A			
N/A	Flare Traversable LT?	N/A	N/A	Flare Traversable RT?	N/A			
N/A	Landing Length (in)	N/A	N/A	DWS Provided?	N/A			
N/A	Landing Width (in)	N/A	N/A	DWS Contrast?	N/A			
N/A	Landing Slope (%)	N/A	N/A	DWS Length (in)	N/A			
N/A	Landing X Slope (%)	N/A	N/A	DWS Full Width?	N/A			
N/A	Landing Curb? (Y/N)	N/A	N/A	DWS Offset (in)	N/A			
N/A	Shared Landing?	N/A						
N/A	Gutter Ponding?	N/A	N/A	Gutter Slope (%)	N/A			
N/A	Gutter Lip Ht (in)	N/A	N/A	Gutter X Slope (%)	N/A			
N/A	Painted X Walk1?	Yes	N/A	Painted X Walk2?	N/A			
	X Walk 1 Direction	To N		X Walk 2 Direction	N/A			
N/A	X Walk 1 Width (in)	114.0	N/A	X Walk 2 Width (in)	N/A

X Walk 1 Slope (%)	6.4		X Walk 2 Slope (%)	N/A			
	X Walk 1 X Slope (%)	4.5		X Walk 2 X Slope (%)	N/A			
N/A	Ramp inside XWalk1?	Yes	N/A	Ramp inside XWalk2?	N/A			
	Road Slope (%)	N/A	N/A	Clear Space?	N/A			
	Road X Slope (%)	N/A	N/A	Clear Space to XWalk (in)	N/A			
N/A	Any Obstructions?	N/A	N/A	Storm Grate/Utility Hazard?	N/A			
	Obstruction Type			Storm Grate/Utility Type				
		N/A			N/A			
			Yes	Surface Condition? (G/P)	Good

Possible Solution	
Possible Solutions:	C
Remove & Replace Entire Ramp.	
	N
	N
	N
	N
	N
Surveyor Notes:	N
N/A	N
	N
	N
	N
PROW/ADA:	N
Not Found, R304.5.1, R304.2.2,	N/
R304.5.3	N
	N
