Access Compliance Report

Public Rights-of-Way

(Curb Ramps)

Intersection ID: 9973	Main Street: CAMPUS_ST	Cross Street: FRENCH_ST	Location: SE
ADA ID: 52379BCE056D	Ramp Type: PerpDiag	Initial Pass/Fail: Fail	Overall Compliance: No
Severity Score: 12.5			
Codes/Mitigation Info/Possible Solution		Field Measurements/Component Compliance

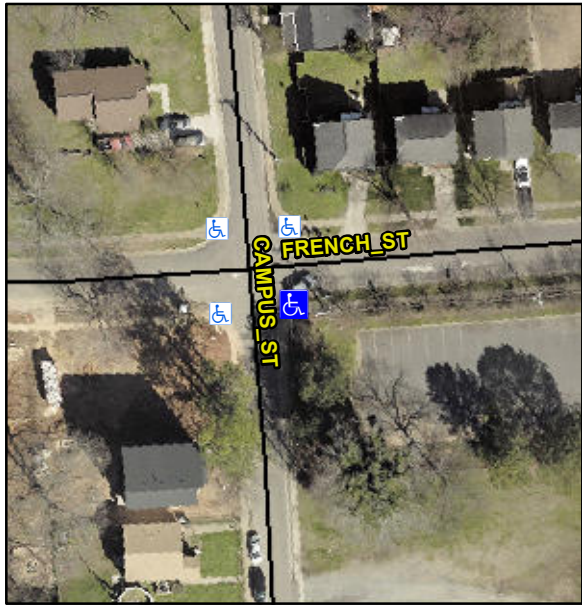
Possible Solutions:							
	Remove & Replace Curb Ramp With Two New Directional Ramps or Equivalent.							
	Surveyor Notes:							
	N/A							
	PROW/ADA:							
	Not Found, R304.2.2							
	Street 1 Name	FRENCH ST	Compliance	Description	Data	Compliance	Description	Data
	Stop Condition-Street 2	StopSign	N/A	Ramp Length (in)	73.0	No	Ramp Slope (%)	9.3
	Street 2 Name	CAMPUS ST	Yes	Ramp Width (in)	48.0	Yes	Ramp XSlope (%)	1.1
	Stop Condition-Street 1	None	N/A	Flare Type LT	N/A	N/A	Flare Type RT	N/A
		N/A	Flare Slope LT (%)	N/A	N/A	Flare Slope RT (%)	N/A	
		N/A	Flare Traversable LT?	N/A	N/A	Flare Traversable RT?	N/A	
		N/A	Landing Length (in)	N/A	N/A	DWS Provided?	N/A	
		N/A	Landing Width (in)	N/A	N/A	DWS Contrast?	N/A	
		N/A	Landing Slope (%)	N/A	N/A	DWS Length (in)	N/A	
		N/A	Landing X Slope (%)	N/A	N/A	DWS Full Width?	N/A	
		N/A	Landing Curb? (Y/N)	N/A	N/A	DWS Offset (in)	N/A	
		N/A	Shared Landing?	N/A

N/A	Gutter Ponding?	N/A	N/A	Gutter Slope (%)	N/A	
		N/A	Gutter Lip Ht (in)	N/A	N/A	Gutter X Slope (%)	N/A	
		N/A	Painted X Walk1?	No	N/A	Painted X Walk2?	No	
			X Walk 1 Direction	To N		X Walk 2 Direction	To W	
		N/A	X Walk 1 Width (in)	N/A	N/A	X Walk 2 Width (in)	N/A	
			X Walk 1 Slope (%)	0.2		X Walk 2 Slope (%)	1.2	
			X Walk 1 X Slope (%)	1.5		X Walk 2 X Slope (%)	0.9	
		N/A	Ramp inside XWalk1?	N/A	N/A	Ramp inside XWalk2?	N/A	
			Road Slope (%)	1.0	N/A	Clear Space?	N/A	
			Road X Slope (%)	0.1	N/A	Clear Space to XWalk (in)	N/A	
		N/A	Any Obstructions?	N/A	N/A	Storm Grate/Utility Hazard?	N/A	
			Obstruction Type			Storm Grate/Utility Type		
				N/A			N/A	
					Yes	Surface Condition? (G/P)	Good	
Total Cost:		\$	3200.00
