Access Compliance Report

Public Rights-of-Way

(Curb Ramps)

| Intersection ID: 47252 | Main Street: GOOSEBERRY_RD | Cross Street: RASPBERRY_KNOLL_DR | Location: S |

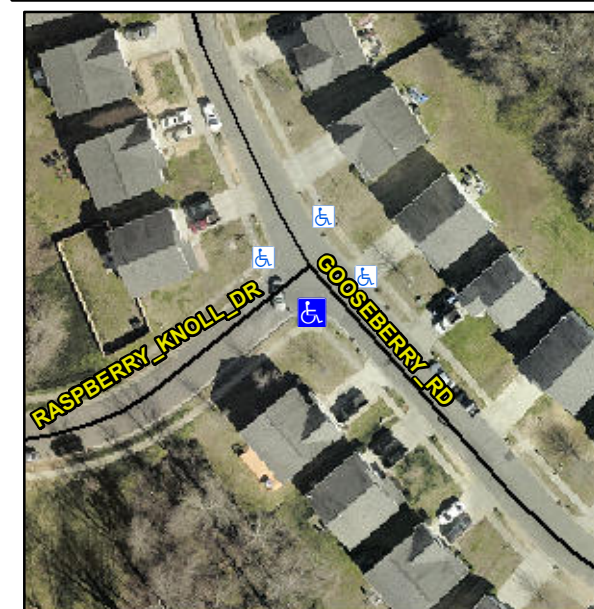
| ADA ID: 524CF9B692A1 | Ramp Type: PerpDiag | Initial Pass/Fail: Fail | Overall Compliance: No |
| Severity Score: 35 | | | |

Not Found, R304.5.1, R304.2.2, R304.5.3

| Compliance | Description | Data | Compliance | Description | Data |
|---|---|---|---|---|---|
| N/A | Ramp Length (in) | 46.0 | No | Ramp Slope (%) | 13.2 |
| No | Ramp Width (in) | 42.0 | No | Ramp XSlope (%) | 2.3 |

Remove & Replace Curb Ramp With Two New Directional Ramps or Equivalent.

Total Cost: \$ 3200.00
