# Access Compliance Report

## Public Rights-of-Way

| Intersection ID: 52311 | Main Street: IMPATIEN_DR | Cross Street: LUPINE_CT | Location: NW |
| ADA ID: 525527CA07B8 | Ramp Type: BlendTrans1 | Initial Pass/Fail: Pass | Overall Compliance: No |

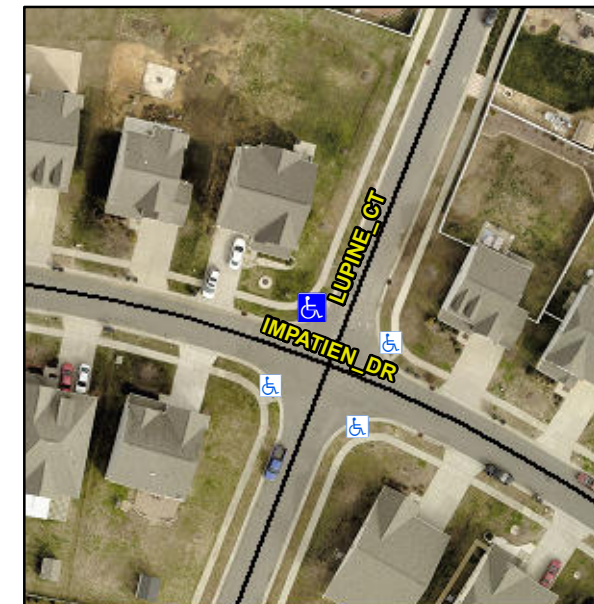
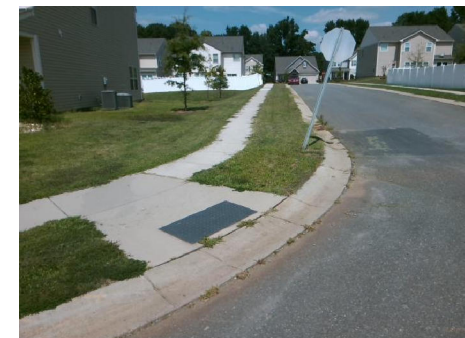
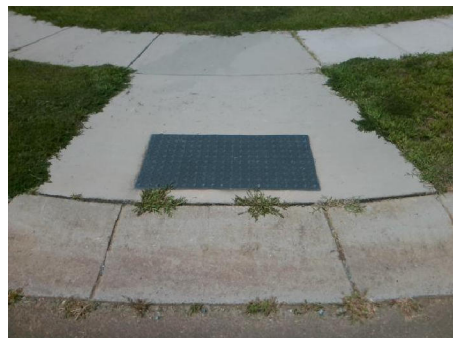
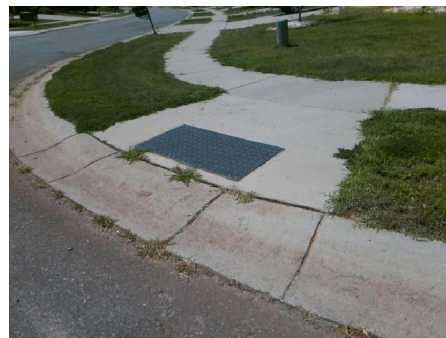
**Not Found, R304.5.3, R304.2.2-Perp, R304.3.2-Para, R305.2, R302.7, R302.7.2, R304.5.4**

| Compliance | Description | Data | Compliance | Description | Data |
|---|---|---|---|---|---|
| Yes | Ramp Width (in) | 48.0 | No | BlendTrans XSlope (%) | 2.9 |
| No | Landing Slope (%) | 3.3 | Yes | DWS Length (in) | 24.0 |
| No | Landing X Slope (%) | 5.2 | Yes | DWS Full Width? | Yes |
| No | Gutter Ponding? | Yes | No | Gutter Slope (%) | 7.3 |
| No | Gutter Lip Ht (in) | 1.3 | No | Gutter X Slope (%) | 2.1 |
| | | | No | Curb Slope (%) | 21.8 |

**Remove & Replace Curb Ramp With Two New Directional Ramps or Equivalent. Remove & Replace Gutter.**
