Access Compliance Report

Public Rights-of-Way

(Curb Ramps)

Intersection ID: 8822	Main Street: GENERAL INDUSTRIAL RD	Cross Street: INDUSTRIAL CENTER CR	Location: W
ADA ID: 525B949D10DE	Ramp Type: PerpDiag	Initial Pass/Fail: Fail	Overall Compliance: No
Severity Score: 8.75			
Codes/Mitigation Info/Possible Solution		Field Measurements/Component Compliance

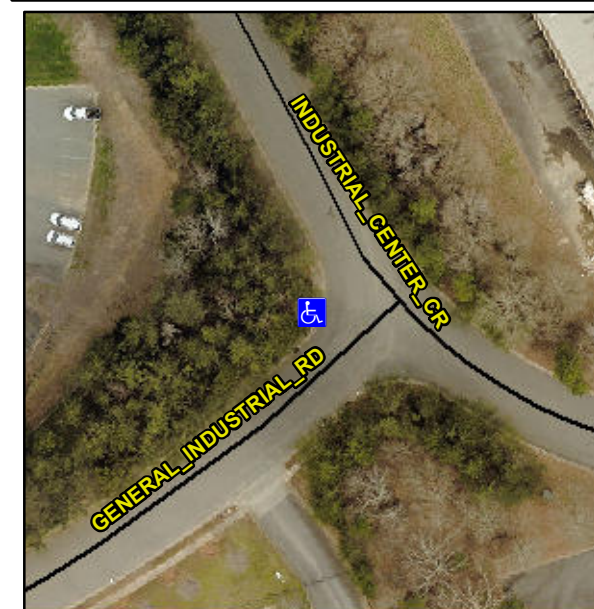
Compliance	Description	Data	Compliance	Description	Data
N/A	Ramp Length (in)	60.0	Yes	Ramp Slope (%)	8.1
No	Ramp Width (in)	46.0	Yes	Ramp XSlope (%)	0.2
N/A	Flare Type LT	N/A	N/A	Flare Type RT	N/A
N/A	Flare Slope LT (%)	N/A	N/A	Flare Slope RT (%)	N/A
N/A	Flare Traversable LT?	N/A	N/A	Flare Traversable RT?	N/A
N/A	Landing Length (in)	N/A	N/A	DWS Provided?	N/A
N/A	Landing Width (in)	N/A	N/A	DWS Contrast?	N/A
N/A	Landing Slope (%)	N/A	N/A	DWS Length (in)	N/A
N/A	Landing X Slope (%)	N/A	N/A	DWS Full Width?	N/A
N/A	Landing Curb? (Y/N)	N/A	N/A	DWS Offset (in)	N/A
N/A	Shared Landing?	N/A			
N/A	Gutter Ponding?	N/A	N/A	Gutter Slope (%)	N/A
N/A	Gutter Lip Ht (in)	N/A	N/A	Gutter X Slope (%)	N/A
N/A	Painted X Walk1?	No	N/A	Painted X Walk2?	No
	X Walk 1 Direction	To S		X Walk 2 Direction	To E
N/A	X Walk 1 Width (in)	N/A	N/A	X Walk 2 Width (in)	N/A
	X Walk 1 Slope (%)	N/A		X Walk 2 Slope (%)	N/A
	X Walk 1 X Slope (%)	N/A		X Walk 2 X Slope (%)	N/A

N/A	Ramp inside XWalk1?	N/A	N/A	Ramp inside XWalk2?	N/A
	Road Slope (%)	1.7	N/A	Clear Space?	N/A
	Road X Slope (%)	2.9	N/A	Clear Space to XWalk (in)	N/A
N/A	Any Obstructions?	N/A	N/A	Storm Grate/Utility Hazard?	N/A
	Obstruction Type			Storm Grate/Utility Type	
		N/A			N/A
		Yes		Surface Condition? (G/P)	Good

Possible Solutions:

Remove & Replace Curb Ramp With Two New Directional Ramps or Equivalent.

R304.5.1
