Access Compliance Report

Public Rights-of-Way

| Intersection ID: 42371 | Main Street: HIGHLAND_CREEK_PY | Cross Street: CHRISTENBURY_RD | Location: NE |
| ADA ID: 525F1EDC75D1 | Ramp Type: PerpDiag | Initial Pass/Fail: Fail | Overall Compliance: No |

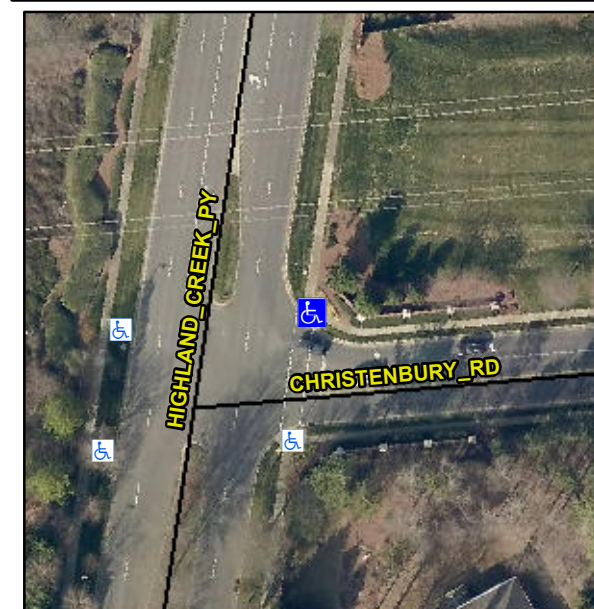
| Severity Score: 22.5 | | | |

| Compliance | Description | Data | Compliance | Description | Data |
|---|---|---|---|---|---|
| N/A | Ramp Length (in) | 42.0 | No | Ramp Slope (%) | 9.8 |
| No | Ramp Width (in) | 46.5 | No | Ramp XSlope (%) | 3.0 |

Remove & Replace Curb Ramp With Two New Directional Ramps or Equivalent.

R304.5.1, R304.2.2, R304.5.3
