Access Compliance Report

Public Rights-of-Way

(Curb Ramps)

Intersection ID: 47090	Main Street: PROVIDENCE_RD_WEST	Cross Street: COVENTRY_COURT_LN	Location: SE
ADA ID: 525FD1396722	Ramp Type: PerpDiag	Initial Pass/Fail: Fail	Overall Compliance: No
Severity Score: 12.5			
Codes/Mitigation Info/Possible Solution		Field Measurements/Component Compliance

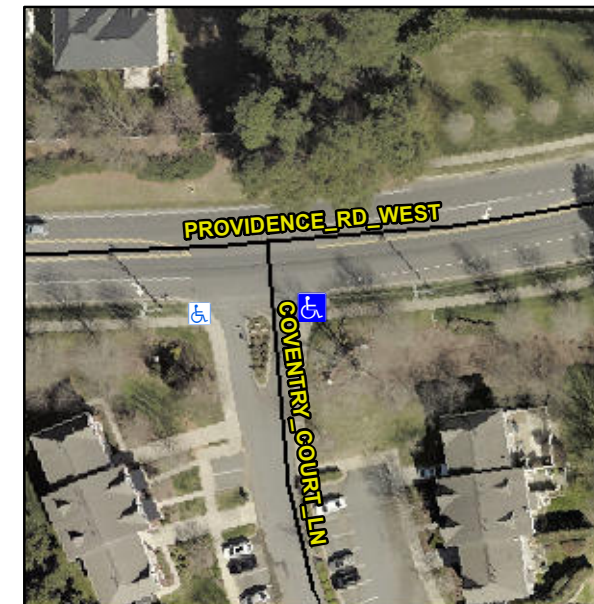
Not Found, R304.2.2

Compliance	Description	Data	Compliance	Description	Data
N/A	Ramp Length (in)	62.0	No	Ramp Slope (%)	8.9
Yes	Ramp Width (in)	48.0	Yes	Ramp XSlope (%)	1.7
N/A	Flare Type LT	N/A	N/A	Flare Type RT	N/A
N/A	Flare Slope LT (%)	N/A	N/A	Flare Slope RT (%)	N/A
N/A	Flare Traversable LT?	N/A	N/A	Flare Traversable RT?	N/A
N/A	Landing Length (in)	N/A	N/A	DWS Provided?	N/A
N/A	Landing Width (in)	N/A	N/A	DWS Contrast?	N/A
N/A	Landing Slope (%)	N/A	N/A	DWS Length (in)	N/A
N/A	Landing X Slope (%)	N/A	N/A	DWS Full Width?	N/A
N/A	Landing Curb? (Y/N)	N/A	N/A	DWS Offset (in)	N/A
N/A	Shared Landing?	N/A			
N/A	Gutter Ponding?	N/A	N/A	Gutter Slope (%)	N/A
N/A	Gutter Lip Ht (in)	N/A	N/A	Gutter X Slope (%)	N/A
N/A	Painted X Walk1?	No	N/A	Painted X Walk2?	No
	X Walk 1 Direction	To N		X Walk 2 Direction	To W
N/A	X Walk 1 Width (in)	N/A	N/A	X Walk 2 Width (in)	N/A
	X Walk 1 Slope (%)	2.6		X Walk 2 Slope (%)	0.7
	X Walk 1 X Slope (%)	0.3		X Walk 2 X Slope (%)	1.1

N/A	Ramp inside XWalk1?	N/A	N/A	Ramp inside XWalk2?	N/A
	Road Slope (%)	1.8	N/A	Clear Space?	N/A
	Road X Slope (%)	2.1	N/A	Clear Space to XWalk (in)	N/A
N/A	Any Obstructions?	N/A	N/A	Storm Grate/Utility Hazard?	N/A
	Obstruction Type			Storm Grate/Utility Type	
		N/A			N/A
		Yes		Surface Condition? (G/P)	Good

Possible Solutions:

Remove & Replace Curb Ramp With Two New Directional Ramps or Equivalent.
