# Access Compliance Report

## Public Rights-of-Way

### (Curb Ramps)

Intersection ID: 2598	Main Street: DRISCOLL_CT	Cross Street: LAGRANDE_DR	Location: NE
ADA ID: 5263CD91AAC1	Ramp Type: PerpDiag	Initial Pass/Fail: Fail	Overall Compliance: No
		Severity Score: 12.5

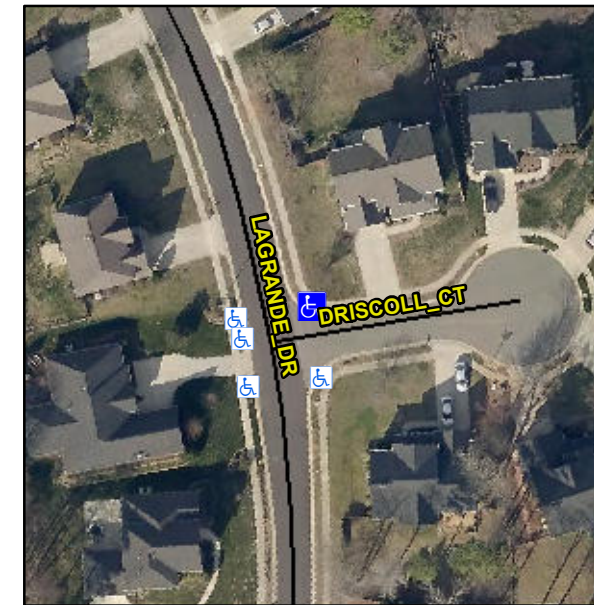
Compliance	Description	Data	Compliance	Description	Data
N/A	Ramp Length (in)	47.0	Yes	Ramp Slope (%)	5.5
Yes	Ramp Width (in)	58.0	No	Ramp XSlope (%)	6.5
N/A	Flare Type LT	N/A	N/A	Flare Type RT	N/A
N/A	Flare Slope LT (%)	N/A	N/A	Flare Slope RT (%)	N/A
N/A	Flare Traversable LT?	N/A	N/A	Flare Traversable RT?	N/A
N/A	Landing Length (in)	N/A	N/A	DWS Provided?	N/A
N/A	Landing Width (in)	N/A	N/A	DWS Contrast?	N/A
N/A	Landing Slope (%)	N/A	N/A	DWS Length (in)	N/A
N/A	Landing X Slope (%)	N/A	N/A	DWS Full Width?	N/A
N/A	Landing Curb? (Y/N)	N/A	N/A	DWS Offset (in)	N/A
N/A	Shared Landing?	N/A			
N/A	Gutter Ponding?	N/A	N/A	Gutter Slope (%)	N/A
N/A	Gutter Lip Ht (in)	N/A	N/A	Gutter X Slope (%)	N/A
N/A	Painted X Walk1?	No	N/A	Painted X Walk2?	No
	X Walk 1 Direction	To W		X Walk 2 Direction	To S
N/A	X Walk 1 Width (in)	N/A	N/A	X Walk 2 Width (in)	N/A
	X Walk 1 Slope (%)	4.4		X Walk 2 Slope (%)	0.4
	X Walk 1 X Slope (%)	3.6		X Walk 2 X Slope (%)	6.1

N/A	Ramp inside XWalk1?	N/A	N/A	Ramp inside XWalk2?	N/A
	Road Slope (%)	5.4	N/A	Clear Space?	N/A
	Road X Slope (%)	2.9	N/A	Clear Space to XWalk (in)	N/A
N/A	Any Obstructions?	N/A	N/A	Storm Grate/Utility Hazard?	N/A
	Obstruction Type			Storm Grate/Utility Type	
		N/A			N/A
			Yes	Surface Condition? (G/P)	Good

**Remove & Replace Curb Ramp With Two New Directional Ramps or Equivalent.**
