Access Compliance Report

Public Rights-of-Way

(Curb Ramps)

Intersection ID: N/A	Main Street: WALTER_ST	Cross Street: WEST_AV	Location: NE
ADA ID: 526CD3FE2753	Ramp Type: PerpDiag	Initial Pass/Fail: Pass	Overall Compliance: No
Codes/Mitigation Info/Possible Solution		Field Measurements/Component Compliance

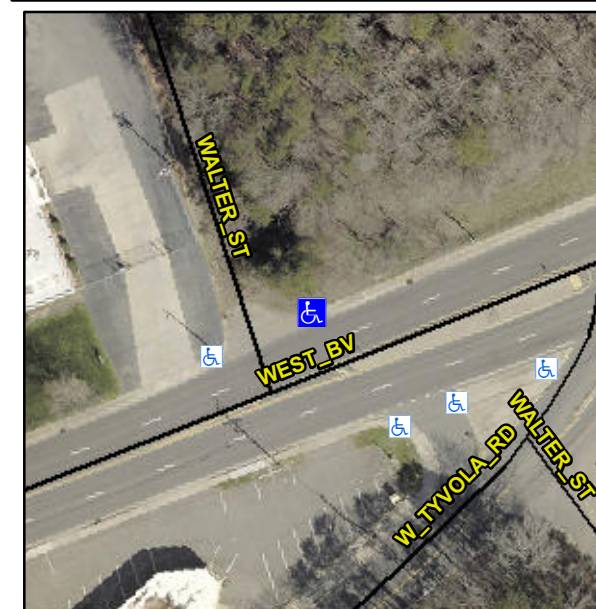
Not Found, R304.2.1, R304.2.2-Perp, R304.3.2-Para, R304.5.3, R305.1.4, R305.2, R302.7

Compliance	Description	Data	Compliance	Description	Data
N/A	Ramp Length (in)	55.0	Yes	Ramp Slope (%)	7.6
Yes	Ramp Width (in)	48.5	Yes	Ramp XSlope (%)	1.1
N/A	Flare Type LT	Sloped	N/A	Flare Type RT	N/A
N/A	Flare Slope LT (%)	5.4	Yes	Flare Slope RT (%)	7.4
N/A	Flare Traversable LT?	No	N/A	Flare Traversable RT?	Yes
No	Landing Length (in)	N/A	Yes	DWS Provided?	Yes
No	Landing Width (in)	N/A	Yes	DWS Contrast?	Yes
No	Landing Slope (%)	N/A	Yes	DWS Length (in)	24.0
No	Landing X Slope (%)	N/A	No	DWS Full Width?	No
N/A	Landing Curb? (Y/N)	No	No	DWS Offset (in)	2.5
N/A	Shared Landing?	No			
No	Gutter Ponding?	Yes	Yes	Gutter Slope (%)	1.2
Yes	Gutter Lip Ht (in)	0.0	Yes	Gutter X Slope (%)	0.4
N/A	Painted X Walk1?	No	N/A	Painted X Walk2?	No
	X Walk 1 Direction	To W		X Walk 2 Direction	To S
N/A	X Walk 1 Width (in)	N/A	N/A	X Walk 2 Width (in)	N/A
	X Walk 1 Slope (%)	0.6		X Walk 2 Slope (%)	1.5
	X Walk 1 X Slope (%)	0.2		X Walk 2 X Slope (%)	0.8

N/A	Ramp inside XWalk1?	N/A	N/A	Ramp inside XWalk2?	N/A
	Road Slope (%)	0.4	N/A	Clear Space?	No
	Road X Slope (%)	2.0	N/A	Clear Space to XWalk (in)	N/A
Yes	Any Obstructions?	No	Yes	Storm Grate/Utility Hazard?	No
	Obstruction Type			Storm Grate/Utility Type	
		N/A			N/A
			Yes	Surface Condition? (G/P)	Good

Remove & Replace Curb Ramp With Two New Directional Ramps or Equivalent.
