# Access Compliance Report

## Public Rights-of-Way

### (Curb Ramps)

| Intersection ID: 15589 | Main Street: MIDDLETON_DR | Cross Street: PROVIDENCE_RD | Location: SE |

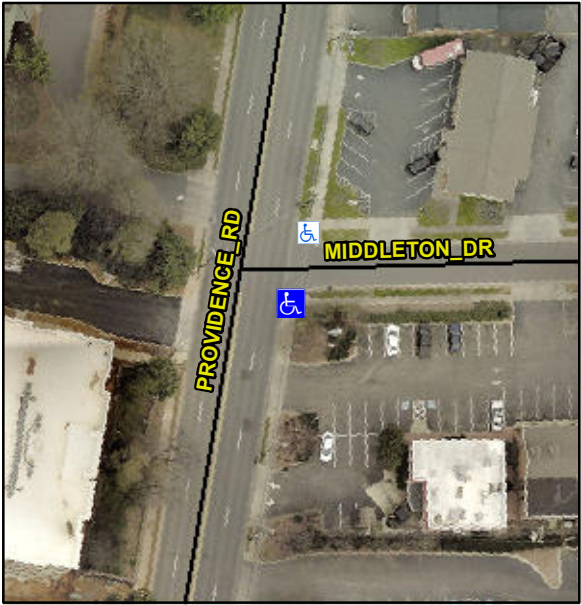
| ADA ID: 528B1D57C513 | Ramp Type: PerpDiag | Initial Pass/Fail: Fail | Overall Compliance: No |
| Severity Score: 21.25 | | | |

| | Remove & Replace Curb Ramp With Two New Directional Ramps or Equivalent. | N/A | Ramp Length (in) | 45.0 | No | Ramp Slope (%) | 11.3 |
| <p>Surveyor Notes:</p> <p>N/A</p> <p>PROW/ADA:</p> <p>Not Found, R304.5.1, R304.2.2</p> | | No | Ramp Width (in) | 39.5 | Yes | Ramp XSlope (%) | 0.5 |
