Access Compliance Report

Public Rights-of-Way

(Curb Ramps)

Intersection ID: N/A	Main Street: MONROE_RD	Cross Street: PRINCESS_ANN_DR	Location: SW
ADA ID: 528D7A119DA3	Ramp Type: PerpDiag	Initial Pass/Fail: Fail	Overall Compliance: No
Severity Score: 12.5			
Codes/Mitigation Info/Possible Solution		Field Measurements/Component Compliance

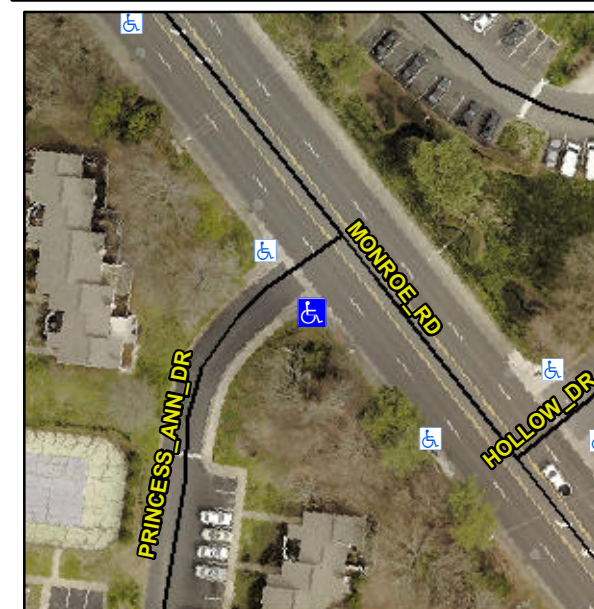
Compliance	Description	Data	Compliance	Description	Data
N/A	Ramp Length (in)	61.0	No	Ramp Slope (%)	9.9
Yes	Ramp Width (in)	48.0	Yes	Ramp XSlope (%)	1.7
N/A	Flare Type LT	N/A	N/A	Flare Type RT	N/A
N/A	Flare Slope LT (%)	N/A	N/A	Flare Slope RT (%)	N/A
N/A	Flare Traversable LT?	N/A	N/A	Flare Traversable RT?	N/A
N/A	Landing Length (in)	N/A	N/A	DWS Provided?	N/A
N/A	Landing Width (in)	N/A	N/A	DWS Contrast?	N/A
N/A	Landing Slope (%)	N/A	N/A	DWS Length (in)	N/A
N/A	Landing X Slope (%)	N/A	N/A	DWS Full Width?	N/A
N/A	Landing Curb? (Y/N)	N/A	N/A	DWS Offset (in)	N/A
N/A	Shared Landing?	N/A			
N/A	Gutter Ponding?	N/A	N/A	Gutter Slope (%)	N/A
N/A	Gutter Lip Ht (in)	N/A	N/A	Gutter X Slope (%)	N/A
N/A	Painted X Walk1?	No	N/A	Painted X Walk2?	No
	X Walk 1 Direction	To NE		X Walk 2 Direction	To NW
N/A	X Walk 1 Width (in)	N/A	N/A	X Walk 2 Width (in)	N/A
	X Walk 1 Slope (%)	0.9		X Walk 2 Slope (%)	3.0
	X Walk 1 X Slope (%)	1.5		X Walk 2 X Slope (%)	2.3

N/A	Ramp inside XWalk1?	N/A	N/A	Ramp inside XWalk2?	N/A
	Road Slope (%)	3.3	N/A	Clear Space?	N/A
	Road X Slope (%)	0.7	N/A	Clear Space to XWalk (in)	N/A
N/A	Any Obstructions?	N/A	N/A	Storm Grate/Utility Hazard?	N/A
	Obstruction Type			Storm Grate/Utility Type	
		N/A			N/A
			Yes	Surface Condition? (G/P)	Good

Possible Solutions:

Remove & Replace Curb Ramp With Two New Directional Ramps or Equivalent.
