Intersection ID: 17979	Main Street: E_WOODLAWN_RD	Cross Street: ROCKFORD_CT	Location:	E
ADA ID: 5294FB89346C	Ramp Type: PerpDiag	Initial Pass/Fail: Fail	Overall Compliance: No	Severity Score: 36.25

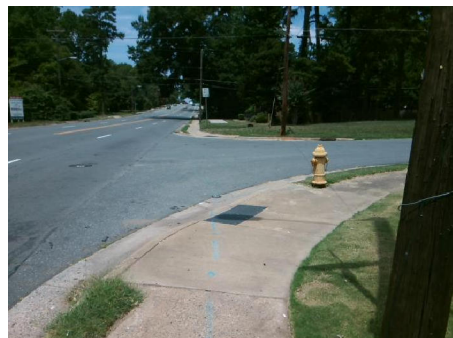
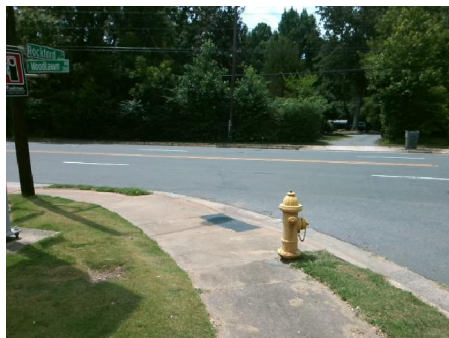
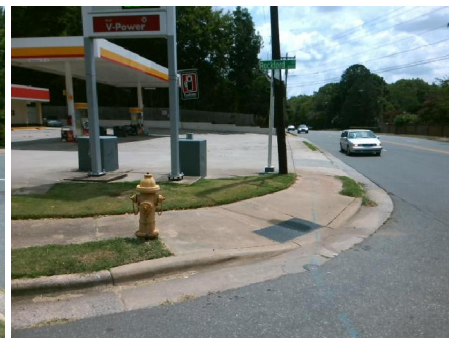
Not Found, R304.5.1, R304.5.3

Compliance	Description	Data	Compliance	Description	Data
N/A	Ramp Length (in)	85.0	Yes	Ramp Slope (%)	7.6
No	Ramp Width (in)	30.0	No	Ramp XSlope (%)	2.4
N/A	Flare Type LT	N/A	N/A	Flare Type RT	N/A
N/A	Flare Slope LT (%)	N/A	N/A	Flare Slope RT (%)	N/A
N/A	Flare Traversable LT?	N/A	N/A	Flare Traversable RT?	N/A
N/A	Landing Length (in)	N/A	N/A	DWS Provided?	N/A
N/A	Landing Width (in)	N/A	N/A	DWS Contrast?	N/A
N/A	Landing Slope (%)	N/A	N/A	DWS Length (in)	N/A
N/A	Landing X Slope (%)	N/A	N/A	DWS Full Width?	N/A
N/A	Landing Curb? (Y/N)	N/A	N/A	DWS Offset (in)	N/A
N/A	Shared Landing?	N/A			
N/A	Gutter Ponding?	N/A	N/A	Gutter Slope (%)	N/A
N/A	Gutter Lip Ht (in)	1.0	N/A	Gutter X Slope (%)	N/A
N/A	Painted X Walk1?	No	N/A	Painted X Walk2?	No
	X Walk 1 Direction	To NW		X Walk 2 Direction	To SW
N/A	X Walk 1 Width (in)	N/A	N/A	X Walk 2 Width (in)	N/A
	X Walk 1 Slope (%)	3.1		X Walk 2 Slope (%)	1.2
	X Walk 1 X Slope (%)	1.3		X Walk 2 X Slope (%)	0.6

N/A	Ramp inside XWalk1?	N/A	N/A	Ramp inside XWalk2?	N/A
	Road Slope (%)	2.7	N/A	Clear Space?	N/A
	Road X Slope (%)	2.8	N/A	Clear Space to XWalk (in)	N/A
N/A	Any Obstructions?	N/A	N/A	Storm Grate/Utility Hazard?	N/A
	Obstruction Type			Storm Grate/Utility Type	
		N/A			N/A
			Yes	Surface Condition? (G/P)	Good

Remove & Replace Curb Ramp With Two New Directional Ramps or Equivalent.
