# Access Compliance Report

## Public Rights-of-Way

### (Curb Ramps)

Intersection ID: 22178	Main Street: INGRAHAM_PL	Cross Street: THORPE_CT	Location: SW
ADA ID: 529C026FCFAF	Ramp Type: PerpDiag	Initial Pass/Fail: Fail	Overall Compliance: No
			Severity Score: 21.25

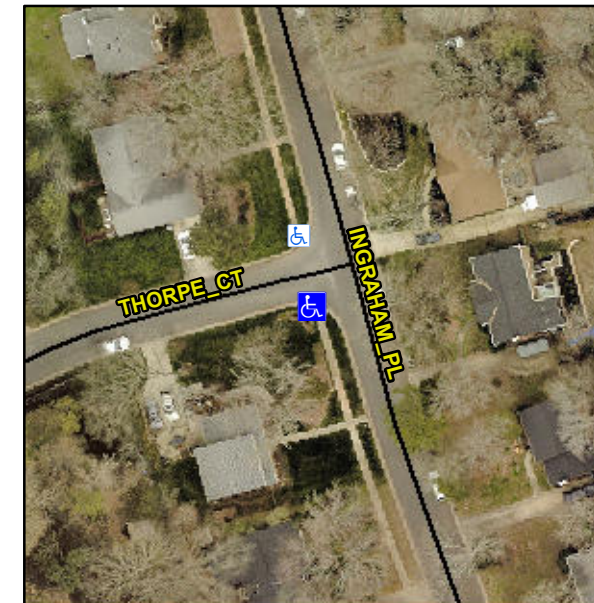
**Not Found, R304.5.1, R304.5.3**

Compliance	Description	Data	Compliance	Description	Data
N/A	Ramp Length (in)	72.0	Yes	Ramp Slope (%)	5.2
No	Ramp Width (in)	43.0	No	Ramp XSlope (%)	5.7
N/A	Flare Type LT	N/A	N/A	Flare Type RT	N/A
N/A	Flare Slope LT (%)	N/A	N/A	Flare Slope RT (%)	N/A
N/A	Flare Traversable LT?	N/A	N/A	Flare Traversable RT?	N/A
N/A	Landing Length (in)	N/A	N/A	DWS Provided?	N/A
N/A	Landing Width (in)	N/A	N/A	DWS Contrast?	N/A
N/A	Landing Slope (%)	N/A	N/A	DWS Length (in)	N/A
N/A	Landing X Slope (%)	N/A	N/A	DWS Full Width?	N/A
N/A	Landing Curb? (Y/N)	N/A	N/A	DWS Offset (in)	N/A
N/A	Shared Landing?	N/A			
N/A	Gutter Ponding?	N/A	N/A	Gutter Slope (%)	N/A
N/A	Gutter Lip Ht (in)	N/A	N/A	Gutter X Slope (%)	N/A
N/A	Painted X Walk1?	No	N/A	Painted X Walk2?	No
	X Walk 1 Direction	To E		X Walk 2 Direction	To N
N/A	X Walk 1 Width (in)	N/A	N/A	X Walk 2 Width (in)	N/A
	X Walk 1 Slope (%)	0.4		X Walk 2 Slope (%)	1.2
	X Walk 1 X Slope (%)	0.7		X Walk 2 X Slope (%)	0.7

N/A	Ramp inside XWalk1?	N/A	N/A	Ramp inside XWalk2?	N/A
	Road Slope (%)	0.8	N/A	Clear Space?	N/A
	Road X Slope (%)	0.2	N/A	Clear Space to XWalk (in)	N/A
N/A	Any Obstructions?	N/A	N/A	Storm Grate/Utility Hazard?	N/A
	Obstruction Type			Storm Grate/Utility Type	
		N/A			N/A
			Yes	Surface Condition? (G/P)	Good

**Remove & Replace Curb Ramp With Two New Directional Ramps or Equivalent.**
