# Access Compliance Report

## Public Rights-of-Way

### (Curb Ramps)

Intersection ID: N/A	Main Street: N COLLEGE ST	Cross Street: E 8TH ST	Location: N
ADA ID: 529EF175B389	Ramp Type: PerpDiag	Initial Pass/Fail: Fail	Overall Compliance: No
Codes/Mitigation Info/Possible Solution		Field Measurements/Component Compliance

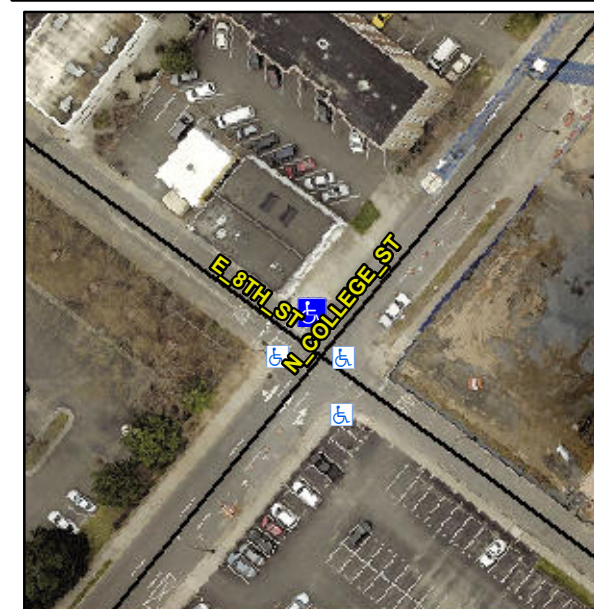
**Not Found, R304.5.1, R304.5.3**

Compliance	Description	Data	Compliance	Description	Data
N/A	Ramp Length (in)	60.0	Yes	Ramp Slope (%)	6.1
No	Ramp Width (in)	41.0	No	Ramp XSlope (%)	2.3
N/A	Flare Type LT	N/A	N/A	Flare Type RT	N/A
N/A	Flare Slope LT (%)	N/A	N/A	Flare Slope RT (%)	N/A
N/A	Flare Traversable LT?	No	N/A	Flare Traversable RT?	No
N/A	Landing Length (in)	N/A	N/A	DWS Provided?	N/A
N/A	Landing Width (in)	N/A	N/A	DWS Contrast?	N/A
N/A	Landing Slope (%)	N/A	N/A	DWS Length (in)	N/A
N/A	Landing X Slope (%)	N/A	N/A	DWS Full Width?	N/A
N/A	Landing Curb? (Y/N)	N/A	N/A	DWS Offset (in)	N/A
N/A	Shared Landing?	N/A			
N/A	Gutter Ponding?	N/A	N/A	Gutter Slope (%)	N/A
N/A	Gutter Lip Ht (in)	N/A	N/A	Gutter X Slope (%)	N/A
N/A	Painted X Walk1?	Yes	N/A	Painted X Walk2?	No
	X Walk 1 Direction	To SW		X Walk 2 Direction	To SE
N/A	X Walk 1 Width (in)	105.0	N/A	X Walk 2 Width (in)	N/A
	X Walk 1 Slope (%)	3.4		X Walk 2 Slope (%)	3.3
	X Walk 1 X Slope (%)	1.3		X Walk 2 X Slope (%)	1.2

N/A	Ramp inside XWalk1?	Yes	N/A	Ramp inside XWalk2?	N/A
	Road Slope (%)	1.2	N/A	Clear Space?	N/A
	Road X Slope (%)	4.1	N/A	Clear Space to XWalk (in)	N/A
N/A	Any Obstructions?	N/A	N/A	Storm Grate/Utility Hazard?	N/A
	Obstruction Type			Storm Grate/Utility Type	
		N/A			N/A
		Yes		Surface Condition? (G/P)	Good

**Remove & Replace Curb Ramp With Two New Directional Ramps or Equivalent.**
