Access Compliance Report

Public Rights-of-Way (Curb Ramps)

Intersection ID: 6263	Main Street: W_SUGAR_CREEK_RD	Cross Street: RUMPLE_RD	Location:	SE
ADA ID: 52A81F7E45D0	Ramp Type: Combination2	Initial Pass/Fail: Fail	Overall Compliance: No	Severity Score: 25

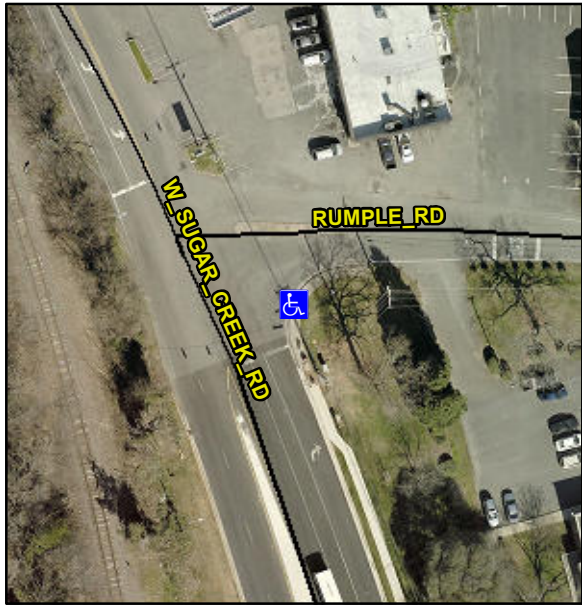
Possible Solutions:		Compliance	Description	Data	Compliance	Description	Data
	Remove & Replace Entire Ramp.		N/A	Ramp Length LT (in)	26.5	N/A	Ramp Length RT (in)	N/A
			Yes	Ramp Width LT (in)	56.0	N/A	Ramp Width RT (in)	N/A
			Yes	Ramp Slope LT (%)	5.6	N/A	Ramp Slope RT (%)	N/A
			No	Ramp XSlope LT (%)	6.3	N/A	Ramp XSlope RT (%)	N/A
			N/A	Ramp Length (in)	60.0	No	Ramp Slope (%)	9.0
			Yes	Ramp Width (in)	48.0	Yes	Ramp XSlope (%)	0.7
	Surveyor Notes:		N/A	Flare Type LT	N/A	N/A	Flare Type RT	N/A
	N/A		N/A	Flare Slope LT (%)	N/A	N/A	Flare Slope RT (%)	N/A
			N/A	Flare Traversable LT?	N/A	N/A	Flare Traversable RT?	N/A
			N/A	Landing Length (in)	N/A	N/A	DWS Provided?	N/A
			N/A	Landing Width (in)	N/A	N/A	DWS Contrast?	N/A
	PROW/ADA:		N/A	Landing Slope (%)	N/A	N/A	DWS Length (in)	N/A
	Not Found, R304.2.2, R304.5.3		N/A	Landing X Slope (%)	N/A	N/A	DWS Full Width?	N/A

N/A	Landing Curb? (Y/N)	N/A	N/A	DWS Offset (in)	N/A
			N/A	Shared Landing?	N/A			
			N/A	Gutter Ponding?	N/A	N/A	Gutter Slope (%)	N/A
			N/A	Gutter Lip Ht (in)	N/A	N/A	Gutter X Slope (%)	N/A
			N/A	Painted X Walk1?	No	N/A	Painted X Walk2?	N/A
Street 1 Name		StopSign		X Walk 1 Direction	To NE		X Walk 2 Direction	N/A
Stop Condition-Street 1		W SUGAR CREEK RD		X Walk 1 Width (in)	N/A		X Walk 2 Width (in)	N/A
Street 2 Name		N/A		X Walk 1 Slope (%)	0.2		X Walk 2 Slope (%)	N/A
Stop Condition-Street 2		N/A		X Walk 1 X Slope (%)	1.0		X Walk 2 X Slope (%)	N/A
Total Cost:		\$ 1600.00	N/A	Ramp inside XWalk1?	N/A	N/A	Ramp inside XWalk2?	N/A
				Road Slope (%)	N/A		Clear Space?	N/A
				Road X Slope (%)	N/A	N/A	Clear Space to XWalk (in)	N/A
						N/A	Any Obstruction?	N/A
							Obstruction Type	N/A
						N/A	Storm Grate/Utility Hazard?	N/A
							Storm Grate/Utility Type	N/A
						Yes	Surface Condition? (G/P)	Good
							Curb Slope (%)	16.2
