# Access Compliance Report

## Public Rights-of-Way

### (Curb Ramps)

Intersection ID: 27190	Main Street: BALLANTYNE COMMONS PY	Cross Street: WOODVIEW CR	Location: NW
ADA ID: 52AA62C3CF6B	Ramp Type: BlendTrans2	Initial Pass/Fail: Fail	Overall Compliance: No
		Severity Score: 8.75

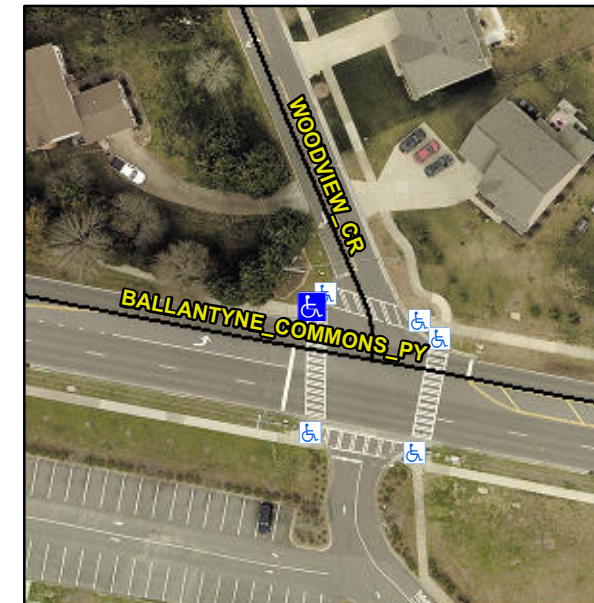
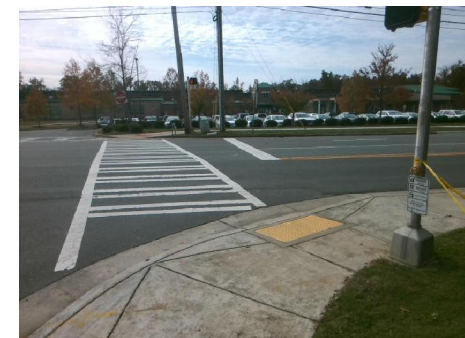
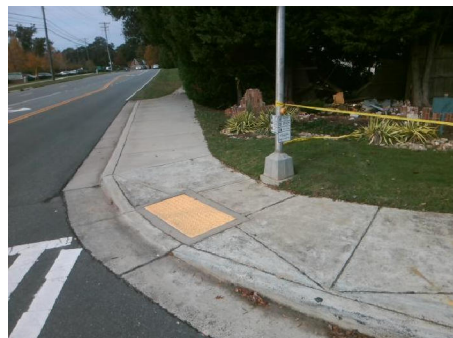
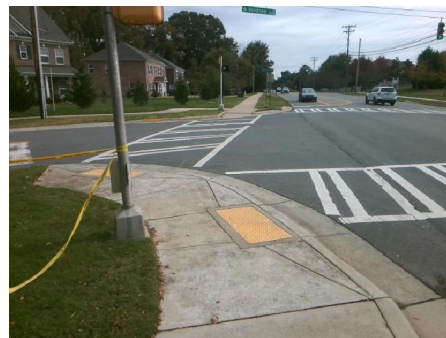
Compliance	Description	Data	Compliance	Description	Data
N/A	Ramp Length (in)	72.0	Yes	BlendTrans Slope (%)	1.9
No	Ramp Width (in)	38.0	Yes	BlendTrans XSlope (%)	0.5
N/A	Flare Type LT	N/A	N/A	Flare Type RT	N/A
N/A	Flare Slope LT (%)	N/A	N/A	Flare Slope RT (%)	N/A
N/A	Flare Traversable LT?	N/A	N/A	Flare Traversable RT?	N/A
N/A	Landing Length (in)	N/A	N/A	DWS Provided?	N/A
N/A	Landing Width (in)	N/A	N/A	DWS Contrast?	N/A
N/A	Landing Slope (%)	N/A	N/A	DWS Length (in)	N/A
N/A	Landing X Slope (%)	N/A	N/A	DWS Full Width?	N/A
N/A	Landing Curb? (Y/N)	N/A	N/A	DWS Offset (in)	N/A
N/A	Shared Landing?	N/A			
N/A	Gutter Ponding?	N/A	N/A	Gutter Slope (%)	N/A
N/A	Gutter Lip Ht (in)	N/A	N/A	Gutter X Slope (%)	N/A
N/A	Painted X Walk1?	Yes	N/A	Painted X Walk2?	N/A
	X Walk 1 Direction	To S		X Walk 2 Direction	N/A
	X Walk 1 Width (in)	109.0		X Walk 2 Width (in)	N/A
	X Walk 1 Slope (%)	1.2		X Walk 2 Slope (%)	N/A
	X Walk 1 X Slope (%)	2.5		X Walk 2 X Slope (%)	N/A

N/A	Ramp inside XWalk1?	Yes	N/A	Ramp inside XWalk2?	N/A
	Road Slope (%)	2.5		Clear Space?	N/A
	Road X Slope (%)	1.2	N/A	Clear Space to XWalk (in)	N/A
N/A	Any Obstructions?	N/A	N/A	Storm Grate/Utility Hazard?	N/A
	Obstruction Type			Storm Grate/Utility Type	
		N/A			N/A
			Yes	Surface Condition? (G/P)	Good
			N/A	Curb Slope (%)	0.7

**Remove & Replace Curb Ramp With Two New Directional Ramps or Equivalent.**

**R304.5.1**
