# Access Compliance Report

## Public Rights-of-Way

### (Curb Ramps)

Intersection ID: 24051	Main Street: DEHAVILLAND_DR	Cross Street: SILVER_DART_PL	Location: NW
ADA ID: 52AB79EEB0D5	Ramp Type: PerpDiag	Initial Pass/Fail: Fail	Overall Compliance: No
Severity Score: 12.5			
Codes/Mitigation Info/Possible Solution		Field Measurements/Component Compliance

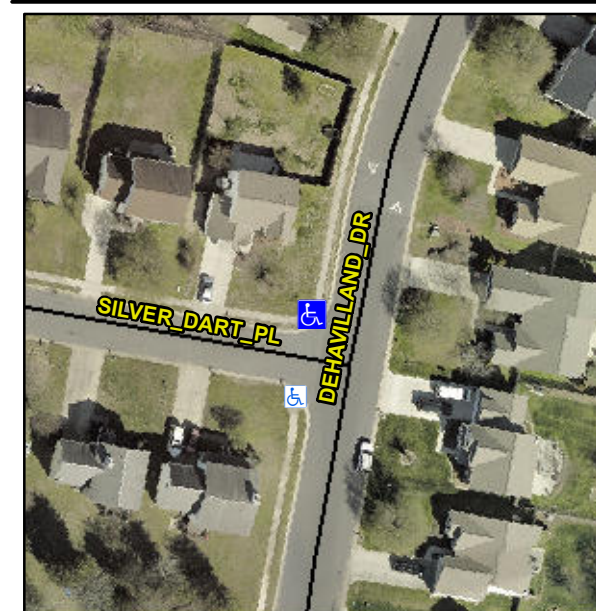
Compliance	Description	Data	Compliance	Description	Data
N/A	Ramp Length (in)	81.0	Yes	Ramp Slope (%)	6.1
Yes	Ramp Width (in)	66.0	No	Ramp XSlope (%)	5.1
N/A	Flare Type LT	N/A	N/A	Flare Type RT	N/A
N/A	Flare Slope LT (%)	N/A	N/A	Flare Slope RT (%)	N/A
N/A	Flare Traversable LT?	N/A	N/A	Flare Traversable RT?	N/A
N/A	Landing Length (in)	N/A	N/A	DWS Provided?	N/A
N/A	Landing Width (in)	N/A	N/A	DWS Contrast?	N/A
N/A	Landing Slope (%)	N/A	N/A	DWS Length (in)	N/A
N/A	Landing X Slope (%)	N/A	N/A	DWS Full Width?	N/A
N/A	Landing Curb? (Y/N)	N/A	N/A	DWS Offset (in)	N/A
N/A	Shared Landing?	N/A			
N/A	Gutter Ponding?	N/A	N/A	Gutter Slope (%)	N/A
N/A	Gutter Lip Ht (in)	N/A	N/A	Gutter X Slope (%)	N/A
N/A	Painted X Walk1?	No	N/A	Painted X Walk2?	No
	X Walk 1 Direction	To SW		X Walk 2 Direction	To SE
N/A	X Walk 1 Width (in)	N/A	N/A	X Walk 2 Width (in)	N/A
	X Walk 1 Slope (%)	0.3		X Walk 2 Slope (%)	2.8
	X Walk 1 X Slope (%)	0.5		X Walk 2 X Slope (%)	2.9

N/A	Ramp inside XWalk1?	N/A	N/A	Ramp inside XWalk2?	N/A
	Road Slope (%)	1.1	N/A	Clear Space?	N/A
	Road X Slope (%)	5.7	N/A	Clear Space to XWalk (in)	N/A
N/A	Any Obstructions?	N/A	N/A	Storm Grate/Utility Hazard?	N/A
	Obstruction Type			Storm Grate/Utility Type	
		N/A			N/A
		Yes		Surface Condition? (G/P)	Good

**Remove & Replace Curb Ramp With Two New Directional Ramps or Equivalent.**

**R304.5.3**
