Access Compliance Report Public Rights-of-Way (Curb Ramps)

Intersection ID: 53286 Main Street: PROSPERITY_CHURCH_RD Cross Street: CRAVEN_THOMAS_RD Location: W ADA ID: 52BBC4F68B97 Ramp Type: Perp Initial Pass/Fail: Pass **Overall Compliance: No Severity Score:** 0.25

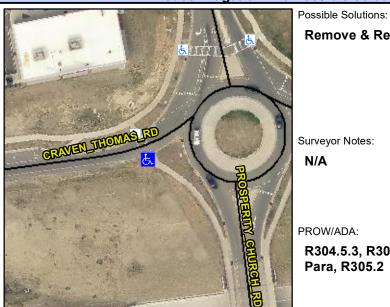
| Remove & Replace Entire Ramp. |
|--|
| R304.5.3, R304.2.2-Perp, R304.3.2- |
| Para, R305.2 |

| Field Measurements/Component Compliance | | | | | | |
|---|---|---|---|---|---|--|
| Yes | Ramp Width (in) | 48.0 | No | Ramp XSlope (%) | 3.8 | |
| No | Landing Slope (%) | 2.4 | Yes | DWS Length (in) | 24.0 | |
| N/A | Landing Curb? (Y/N) | No | No | DWS Offset (in) | 4.5 | |

| Remove & Replace Entire Ramp. |

Total Cost: 1850.00
