Access Compliance Report Public Rights-of-Way (Curb Ramps)

Intersection ID: 12173 Main Street: TEANECK_PL Cross Street: WICKVILLE_DR Location: NE

ADA ID: 52C055B3073C Ramp Type: BlendTrans1 Initial Pass/Fail: Fail Overall Compliance: No Severity Score: 33.75

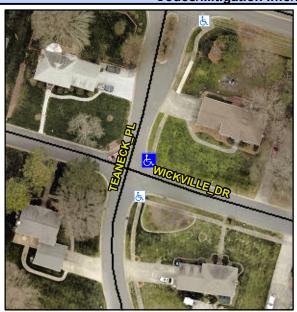
PROW/ADA:
Not Found, R304.5.1, R304.5.3

Compliance Description Data Compliance Description Data Ramp Length (in) Yes BlendTrans Slope (%) N/A 86.5 1.2 42.0 No No Ramp Width (in) BlendTrans XSlope (%) 7.7 N/A N/A Flare Type LT N/A Flare Type RT N/A N/A Flare Slope LT (%) N/A N/A Flare Slope RT (%) N/A N/A Flare Traversable LT? N/A N/A Flare Traversable RT? N/A N/A Landing Length (in) N/A N/A **DWS Provided?** N/A N/A Landing Width (in) N/A N/A **DWS Contrast?** N/A N/A N/A N/A Landing Slope (%) DWS Length (in) N/A N/A Landing X Slope (%) N/A N/A DWS Full Width? N/A N/A Landing Curb? (Y/N) N/A N/A DWS Offset (in) N/A N/A N/A Shared Landing? N/A **Gutter Ponding?** N/A N/A Gutter Slope (%) N/A N/A Gutter Lip Ht (in) N/A N/A Gutter X Slope (%) N/A N/A Painted X Walk1? No N/A Painted X Walk2? N/A X Walk 1 Direction To S X Walk 2 Direction N/A N/A X Walk 1 Width (in) X Walk 2 Width (in) N/A X Walk 1 Slope (%) X Walk 2 Slope (%) N/A 6.4 X Walk 1 X Slope (%) 3.6 X Walk 2 X Slope (%) N/A N/A N/A Ramp inside XWalk2? N/A Ramp inside XWalk1? N/A Road Slope (%) 3.6 Clear Space? N/A N/A Road X Slope (%) 6.4 Clear Space to XWalk (in) N/A N/A N/A N/A Any Obstructions? Storm Grate/Utility Hazard? N/A **Obstruction Type** Storm Grate/Utility Type N/A N/A Yes Surface Condition? (G/P) Good No Curb Slope (%) 12.5

Remove & Replace Curb Ramp With
Two New Directional Ramps or
Equivalent.
