Access Compliance Report

Public Rights-of-Way

(Curb Ramps)

Intersection ID: 42551	Main Street: ENEIDA_SUE_DR	Cross Street: HANNAH_RAE_CT	Location: NE
ADA ID: 52C2CCC898A9	Ramp Type: PerpDiag	Initial Pass/Fail: Fail	Overall Compliance: No
Severity Score: 10			
Codes/Mitigation Info/Possible Solution		Field Measurements/Component Compliance

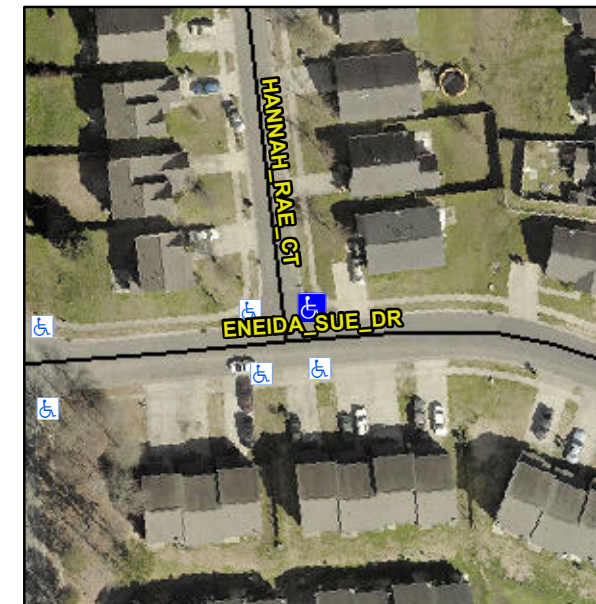
Compliance	Description	Data	Compliance	Description	Data
N/A	Ramp Length (in)	49.0	Yes	Ramp Slope (%)	6.9
No	Ramp Width (in)	39.0	No	Ramp XSlope (%)	4.6
N/A	Flare Type LT	N/A	N/A	Flare Type RT	N/A
N/A	Flare Slope LT (%)	N/A	N/A	Flare Slope RT (%)	N/A
N/A	Flare Traversable LT?	N/A	N/A	Flare Traversable RT?	N/A
N/A	Landing Length (in)	N/A	N/A	DWS Provided?	N/A
N/A	Landing Width (in)	N/A	N/A	DWS Contrast?	N/A
N/A	Landing Slope (%)	N/A	N/A	DWS Length (in)	N/A
N/A	Landing X Slope (%)	N/A	N/A	DWS Full Width?	N/A
N/A	Landing Curb? (Y/N)	N/A	N/A	DWS Offset (in)	N/A
N/A	Shared Landing?	N/A			
N/A	Gutter Ponding?	N/A	N/A	Gutter Slope (%)	N/A
N/A	Gutter Lip Ht (in)	N/A	N/A	Gutter X Slope (%)	N/A
N/A	Painted X Walk1?	No	N/A	Painted X Walk2?	No
	X Walk 1 Direction	To W		X Walk 2 Direction	To S
N/A	X Walk 1 Width (in)	N/A	N/A	X Walk 2 Width (in)	N/A
	X Walk 1 Slope (%)	7.2		X Walk 2 Slope (%)	0.3
	X Walk 1 X Slope (%)	1.1		X Walk 2 X Slope (%)	6.6

N/A	Ramp inside XWalk1?	N/A	N/A	Ramp inside XWalk2?	N/A
	Road Slope (%)	4.3	N/A	Clear Space?	N/A
	Road X Slope (%)	8.0	N/A	Clear Space to XWalk (in)	N/A
N/A	Any Obstructions?	N/A	N/A	Storm Grate/Utility Hazard?	N/A
	Obstruction Type			Storm Grate/Utility Type	
		N/A			N/A
			Yes	Surface Condition? (G/P)	Good

Possible Solutions:

Remove & Replace Curb Ramp With Two New Directional Ramps or Equivalent.
