Access Compliance Report

Public Rights-of-Way

(Curb Ramps)

Intersection ID: 51342	Main Street: MCMULLEN_WY	Cross Street: MONROE_RD	Location: SW
ADA ID: 52C80C334AEA	Ramp Type: PerpDiag	Initial Pass/Fail: Fail	Overall Compliance: No
Severity Score: 22.5			
Codes/Mitigation Info/Possible Solution		Field Measurements/Component Compliance

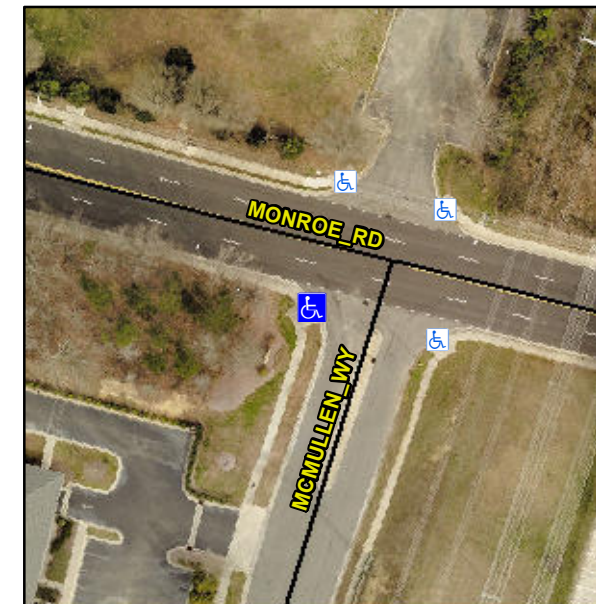
Not Found, R304.5.1, R304.2.2, R304.5.3

Compliance	Description	Data	Compliance	Description	Data
N/A	Ramp Length (in)	96.0	No	Ramp Slope (%)	8.5
No	Ramp Width (in)	47.0	No	Ramp XSlope (%)	3.6
N/A	Flare Type LT	N/A	N/A	Flare Type RT	N/A
N/A	Flare Slope LT (%)	N/A	N/A	Flare Slope RT (%)	N/A
N/A	Flare Traversable LT?	N/A	N/A	Flare Traversable RT?	N/A
N/A	Landing Length (in)	N/A	N/A	DWS Provided?	N/A
N/A	Landing Width (in)	N/A	N/A	DWS Contrast?	N/A
N/A	Landing Slope (%)	N/A	N/A	DWS Length (in)	N/A
N/A	Landing X Slope (%)	N/A	N/A	DWS Full Width?	N/A
N/A	Landing Curb? (Y/N)	N/A	N/A	DWS Offset (in)	N/A
N/A	Shared Landing?	N/A			
N/A	Gutter Ponding?	N/A	N/A	Gutter Slope (%)	N/A
N/A	Gutter Lip Ht (in)	N/A	N/A	Gutter X Slope (%)	N/A
N/A	Painted X Walk1?	No	N/A	Painted X Walk2?	No
	X Walk 1 Direction	To SE		X Walk 2 Direction	To NE
N/A	X Walk 1 Width (in)	N/A	N/A	X Walk 2 Width (in)	N/A
	X Walk 1 Slope (%)	3.1		X Walk 2 Slope (%)	2.5
	X Walk 1 X Slope (%)	0.7		X Walk 2 X Slope (%)	4.7

N/A	Ramp inside XWalk1?	N/A	N/A	Ramp inside XWalk2?	N/A
	Road Slope (%)	2.8	N/A	Clear Space?	N/A
	Road X Slope (%)	2.8	N/A	Clear Space to XWalk (in)	N/A
N/A	Any Obstructions?	N/A	N/A	Storm Grate/Utility Hazard?	N/A
	Obstruction Type			Storm Grate/Utility Type	
		N/A			N/A
			Yes	Surface Condition? (G/P)	Good

Possible Solutions:

Remove & Replace Curb Ramp With Two New Directional Ramps or Equivalent.
