Access Compliance Report

Public Rights-of-Way

(Curb Ramps)

Intersection ID: 16874	Main Street: IDLEWILD_RD	Cross Street: LYNFIELD_DR	Location: E
ADA ID: 52C9B1335B82	Ramp Type: PerpDiag	Initial Pass/Fail: Fail	Overall Compliance: No
Severity Score: 12.5			
Codes/Mitigation Info/Possible Solution		Field Measurements/Component Compliance

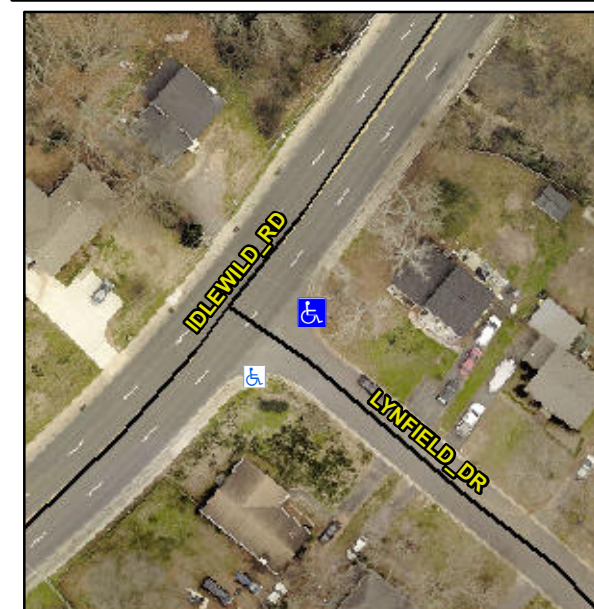
Compliance	Description	Data	Compliance	Description	Data
N/A	Ramp Length (in)	60.0	No	Ramp Slope (%)	9.9
Yes	Ramp Width (in)	48.0	Yes	Ramp XSlope (%)	0.5
N/A	Flare Type LT	N/A	N/A	Flare Type RT	N/A
N/A	Flare Slope LT (%)	N/A	N/A	Flare Slope RT (%)	N/A
N/A	Flare Traversable LT?	N/A	N/A	Flare Traversable RT?	N/A
N/A	Landing Length (in)	N/A	N/A	DWS Provided?	N/A
N/A	Landing Width (in)	N/A	N/A	DWS Contrast?	N/A
N/A	Landing Slope (%)	N/A	N/A	DWS Length (in)	N/A
N/A	Landing X Slope (%)	N/A	N/A	DWS Full Width?	N/A
N/A	Landing Curb? (Y/N)	N/A	N/A	DWS Offset (in)	N/A
N/A	Shared Landing?	N/A			
N/A	Gutter Ponding?	N/A	N/A	Gutter Slope (%)	N/A
N/A	Gutter Lip Ht (in)	N/A	N/A	Gutter X Slope (%)	N/A
N/A	Painted X Walk1?	No	N/A	Painted X Walk2?	No
	X Walk 1 Direction	To NW		X Walk 2 Direction	To SW
N/A	X Walk 1 Width (in)	N/A	N/A	X Walk 2 Width (in)	N/A
	X Walk 1 Slope (%)	4.8		X Walk 2 Slope (%)	1.9
	X Walk 1 X Slope (%)	1.6		X Walk 2 X Slope (%)	2.9

N/A	Ramp inside XWalk1?	N/A	N/A	Ramp inside XWalk2?	N/A
	Road Slope (%)	1.3	N/A	Clear Space?	N/A
	Road X Slope (%)	5.0	N/A	Clear Space to XWalk (in)	N/A
N/A	Any Obstructions?	N/A	N/A	Storm Grate/Utility Hazard?	N/A
	Obstruction Type			Storm Grate/Utility Type	
		N/A			N/A
		Yes		Surface Condition? (G/P)	Good

Possible Solutions:

Remove & Replace Curb Ramp With Two New Directional Ramps or Equivalent.

R304.2.2
