Intersection ID: 29457	Main Street: N_DAVIDSON_ST	Cross Street: GARDEN_DISTRICT_DR	Location:	S
ADA ID: 52F02EB7D8A2	Ramp Type: PerpDiag	Initial Pass/Fail: Fail	Overall Compliance: No	Severity Score: 21.25

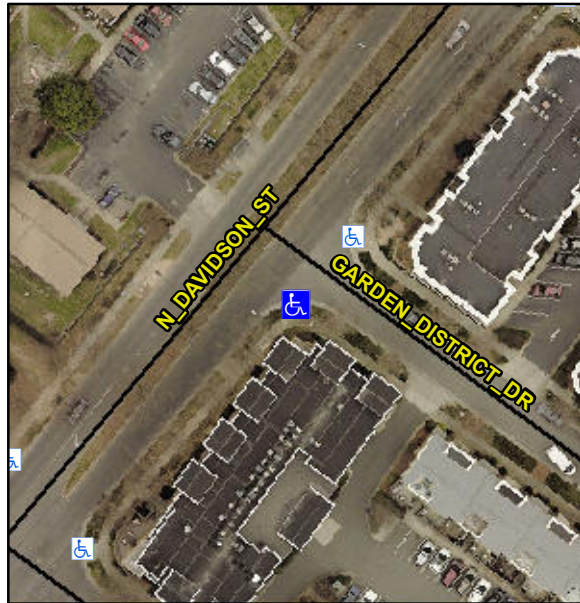
Not Found, R304.5.1, R304.5.3

Compliance	Description	Data	Compliance	Description	Data
N/A	Ramp Length (in)	71.0	Yes	Ramp Slope (%)	6.4
No	Ramp Width (in)	38.0	No	Ramp XSlope (%)	5.8
N/A	Flare Type LT	N/A	N/A	Flare Type RT	N/A
N/A	Flare Slope LT (%)	N/A	N/A	Flare Slope RT (%)	N/A
N/A	Flare Traversable LT?	N/A	N/A	Flare Traversable RT?	N/A
N/A	Landing Length (in)	N/A	N/A	DWS Provided?	N/A
N/A	Landing Width (in)	N/A	N/A	DWS Contrast?	N/A
N/A	Landing Slope (%)	N/A	N/A	DWS Length (in)	N/A
N/A	Landing X Slope (%)	N/A	N/A	DWS Full Width?	N/A
N/A	Landing Curb? (Y/N)	N/A	N/A	DWS Offset (in)	N/A
N/A	Shared Landing?	N/A			
N/A	Gutter Ponding?	N/A	N/A	Gutter Slope (%)	N/A
N/A	Gutter Lip Ht (in)	N/A	N/A	Gutter X Slope (%)	N/A
N/A	Painted X Walk1?	No	N/A	Painted X Walk2?	No
	X Walk 1 Direction	To NE		X Walk 2 Direction	To NW
N/A	X Walk 1 Width (in)	N/A	N/A	X Walk 2 Width (in)	N/A
	X Walk 1 Slope (%)	0.2		X Walk 2 Slope (%)	1.8
	X Walk 1 X Slope (%)	4.7		X Walk 2 X Slope (%)	0.2

N/A	Ramp inside XWalk1?	N/A	N/A	Ramp inside XWalk2?	N/A
	Road Slope (%)	2.7	N/A	Clear Space?	N/A
	Road X Slope (%)	2.3	N/A	Clear Space to XWalk (in)	N/A
N/A	Any Obstructions?	N/A	N/A	Storm Grate/Utility Hazard?	N/A
	Obstruction Type			Storm Grate/Utility Type	
		N/A			N/A
			Yes	Surface Condition? (G/P)	Good

Possible Solutions:

Remove & Replace Curb Ramp With Two New Directional Ramps or Equivalent.
