Access Compliance Report

Public Rights-of-Way (Curb Ramps)

| Intersection ID: 45240 | Main Street: BEGONIA_DR | Cross Street: BLAZE_MANOR_LN | Location: W |
| ADA ID: 52F0F0CC4AAE | Ramp Type: PerpDiag | Initial Pass/Fail: Fail | Overall Compliance: No |

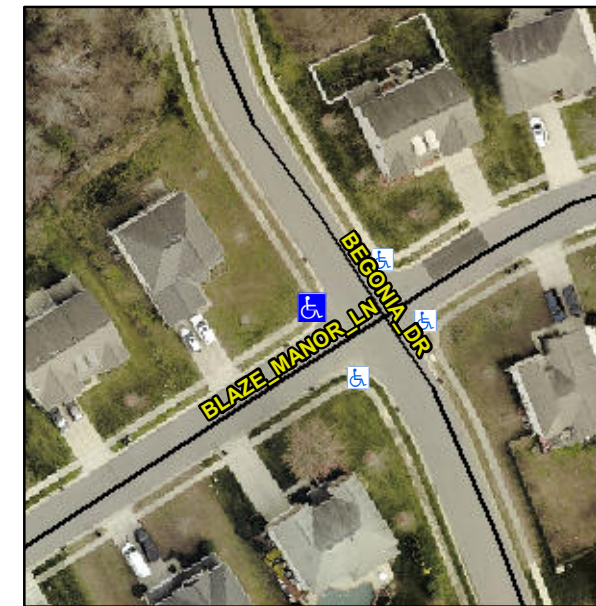
Not Found, R304.5.1, R304.2.2

| Compliance | Description | Data | Compliance | Description | Data |
|---|---|---|---|---|---|
| N/A | Ramp Length (in) | 47.0 | No | Ramp Slope (%) | 9.0 |
| No | Ramp Width (in) | 47.5 | Yes | Ramp XSlope (%) | 1.9 |

Remove & Replace Curb Ramp With Two New Directional Ramps or Equivalent.
