# Access Compliance Report

## Public Rights-of-Way

### (Curb Ramps)

| Intersection ID: 11541 | Main Street: W_9TH_ST | Cross Street: N_PINE_ST | Location: N |

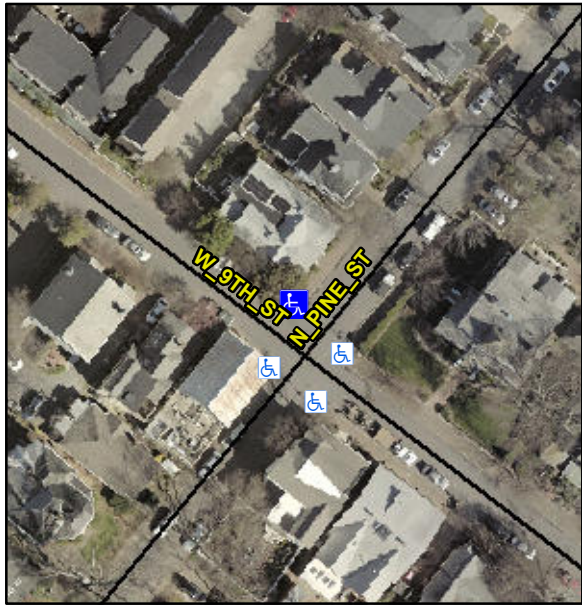
| ADA ID: 52F878FCE960 | Ramp Type: PerpDiag | Initial Pass/Fail: Fail | Overall Compliance: No |

| Codes/Mitigation Info/Possible Solution | | | Field Measurements/Component Compliance | | | | | |
|---|---|---|---|---|---|---|---|---|
| | Remove & Replace Curb Ramp With Two New Directional Ramps or Equivalent. | | N/A | Ramp Length (in) | 58.0 | No | Ramp Slope (%) | 11.7 |
| | | | Yes | Ramp Width (in) | 72.0 | No | Ramp XSlope (%) | 3.1 |
| Not Found, R304.2.2, R304.5.3 | | | N/A | Gutter Lip Ht (in) | N/A | N/A | Gutter X Slope (%) | N/A |
