# Access Compliance Report

## Public Rights-of-Way

### (Curb Ramps)

Intersection ID: 21161	Main Street: FOLGER_DR	Cross Street: PROVIDENCE_RD	Location: SW
ADA ID: 53005EB79496	Ramp Type: Directional1	Initial Pass/Fail: Fail	Overall Compliance: No
		Severity Score: 12.5

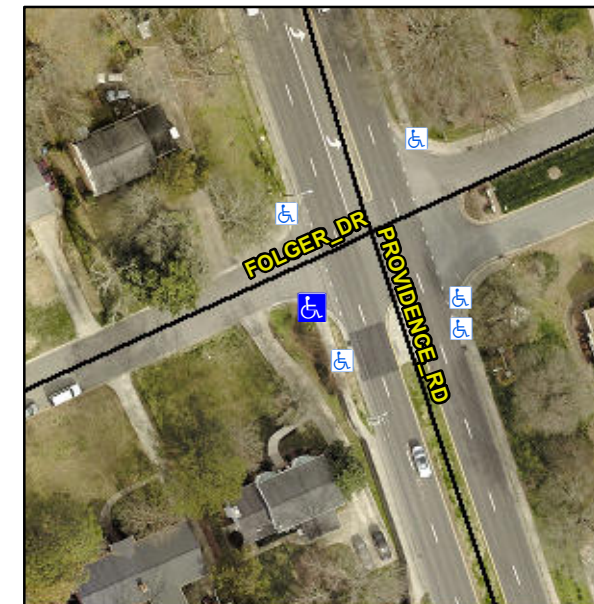
**R304.2.2**

Compliance	Description	Data	Compliance	Description	Data
N/A	Ramp Length (in)	80.0	N/A	Grade Break?	N/A
Yes	Ramp Width (in)	72.0	N/A	Grade Break Slope (%)	0.0
No	Ramp Slope (%)	10.5	N/A	Grade Break XSlope (%)	0.0
Yes	Ramp XSlope (%)	0.7			
N/A	Flare Type LT	N/A	N/A	Flare Type RT	N/A
N/A	Flare Slope LT (%)	N/A	N/A	Flare Slope RT (%)	0.0
N/A	Flare Traversable LT?	N/A	N/A	Flare Traversable RT?	N/A
N/A	Landing Length (in)	0.0	N/A	DWS Provided?	N/A
N/A	Landing Width (in)	0.0	N/A	DWS Contrast?	N/A
N/A	Landing Slope (%)	0.0	N/A	DWS Length (in)	N/A
N/A	Landing X Slope (%)	0.0	N/A	DWS Full Width?	N/A
N/A	Landing Curb? (Y/N)	N/A	N/A	DWS Offset LT (in)	N/A
N/A	Shared Landing?	N/A	N/A	DWS Offset RT (in)	N/A
N/A	Gutter Ponding?	0.0	N/A	Gutter Slope (%)	N/A
N/A	Gutter Lip Ht (in)	0.0	N/A	Gutter X Slope (%)	N/A
N/A	Painted X Walk1?	No		Road Slope (%)	2.8
	X Walk 1 Direction	To NW		Road X Slope (%)	5.4
	X Walk 1 Width (in)	N/A		Clear Space?	N/A

X Walk 1 Slope (%)	2.8	N/A	Clear Space to XWalk (in)	N/A
	X Walk 1 X Slope (%)	5.4	N/A	Storm Grate/Utility Hazard?	N/A
N/A	Ramp inside XWalk1?	N/A		Storm Grate/Utility Type	
N/A	Any Obstructions?	N/A			N/A
	Obstruction Type		Yes	Surface Condition? (G/P)	Good
			N/A	Curb Slope (%)	3.1

**Remove & Replace Entire Ramp.**
