Access Compliance Report

Public Rights-of-Way (Curb Ramps)

Intersection ID: 48283	Main Street: MEADOWMONT_VIEW_DR	Cross Street: MEADOWMONT_VIEW_DR	Location: NE
ADA ID: 5313FF74533F	Ramp Type: PerpDiag	Initial Pass/Fail: Fail	Overall Compliance: No
Severity Score: 8.75			
Codes/Mitigation Info/Possible Solution		Field Measurements/Component Compliance

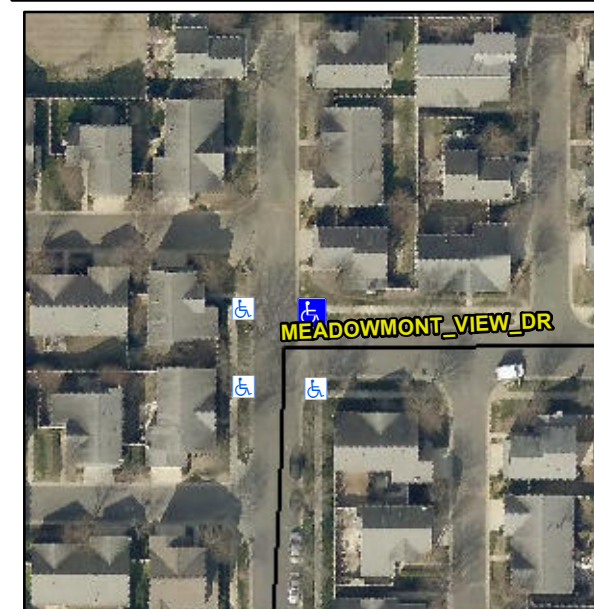
Not Found, R304.5.1

Compliance	Description	Data	Compliance	Description	Data
N/A	Ramp Length (in)	72.0	Yes	Ramp Slope (%)	7.8
No	Ramp Width (in)	42.0	Yes	Ramp XSlope (%)	0.2
N/A	Flare Type LT	N/A	N/A	Flare Type RT	N/A
N/A	Flare Slope LT (%)	N/A	N/A	Flare Slope RT (%)	N/A
N/A	Flare Traversable LT?	N/A	N/A	Flare Traversable RT?	N/A
N/A	Landing Length (in)	N/A	N/A	DWS Provided?	N/A
N/A	Landing Width (in)	N/A	N/A	DWS Contrast?	N/A
N/A	Landing Slope (%)	N/A	N/A	DWS Length (in)	N/A
N/A	Landing X Slope (%)	N/A	N/A	DWS Full Width?	N/A
N/A	Landing Curb? (Y/N)	N/A	N/A	DWS Offset (in)	N/A
N/A	Shared Landing?	N/A			
N/A	Gutter Ponding?	N/A	N/A	Gutter Slope (%)	N/A
N/A	Gutter Lip Ht (in)	N/A	N/A	Gutter X Slope (%)	N/A
N/A	Painted X Walk1?	No	N/A	Painted X Walk2?	No
	X Walk 1 Direction	To W		X Walk 2 Direction	To S
N/A	X Walk 1 Width (in)	N/A	N/A	X Walk 2 Width (in)	N/A
	X Walk 1 Slope (%)	0.2		X Walk 2 Slope (%)	0.2
	X Walk 1 X Slope (%)	1.5		X Walk 2 X Slope (%)	1.1

N/A	Ramp inside XWalk1?	N/A	N/A	Ramp inside XWalk2?	N/A
	Road Slope (%)	0.6	N/A	Clear Space?	N/A
	Road X Slope (%)	1.6	N/A	Clear Space to XWalk (in)	N/A
N/A	Any Obstructions?	N/A	N/A	Storm Grate/Utility Hazard?	N/A
	Obstruction Type			Storm Grate/Utility Type	
		N/A			N/A
			Yes	Surface Condition? (G/P)	Good

Possible Solutions:

Remove & Replace Curb Ramp With Two New Directional Ramps or Equivalent.
