Access Compliance Report

Public Rights-of-Way

(Curb Ramps)

Intersection ID: 14474	Main Street: BROOKHILL_RD	Cross Street: S_TRYON_ST	Location: W
ADA ID: 53199D63C8C8	Ramp Type: PerpDiag	Initial Pass/Fail: Fail	Overall Compliance: No
Severity Score: 36.25			
Codes/Mitigation Info/Possible Solution		Field Measurements/Component Compliance

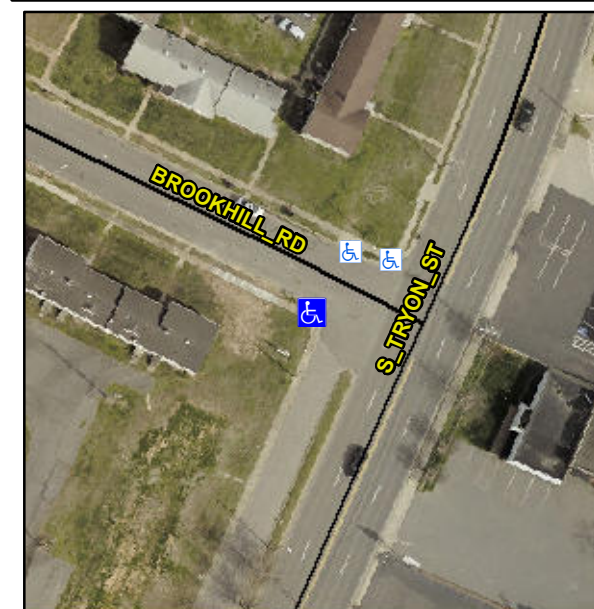
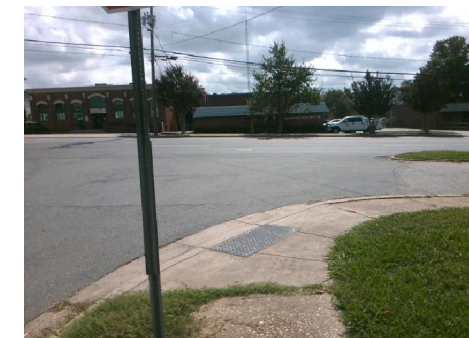
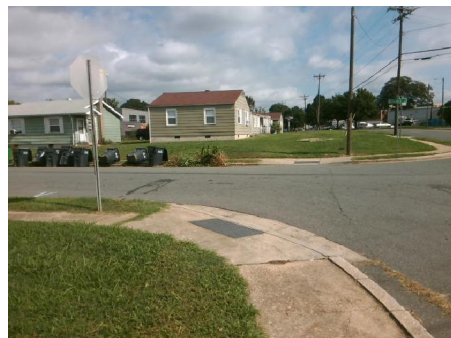
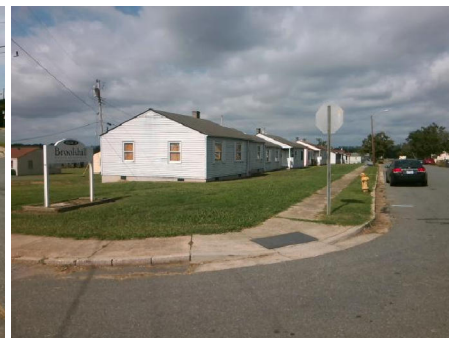
Compliance	Description	Data	Compliance	Description	Data
N/A	Ramp Length (in)	58.0	Yes	Ramp Slope (%)	5.9
No	Ramp Width (in)	31.0	No	Ramp XSlope (%)	2.6
N/A	Flare Type LT	N/A	N/A	Flare Type RT	N/A
N/A	Flare Slope LT (%)	N/A	N/A	Flare Slope RT (%)	N/A
N/A	Flare Traversable LT?	N/A	N/A	Flare Traversable RT?	N/A
N/A	Landing Length (in)	N/A	N/A	DWS Provided?	N/A
N/A	Landing Width (in)	N/A	N/A	DWS Contrast?	N/A
N/A	Landing Slope (%)	N/A	N/A	DWS Length (in)	N/A
N/A	Landing X Slope (%)	N/A	N/A	DWS Full Width?	N/A
N/A	Landing Curb? (Y/N)	N/A	N/A	DWS Offset (in)	N/A
N/A	Shared Landing?	N/A			
N/A	Gutter Ponding?	N/A	N/A	Gutter Slope (%)	N/A
N/A	Gutter Lip Ht (in)	N/A	N/A	Gutter X Slope (%)	N/A
N/A	Painted X Walk1?	No	N/A	Painted X Walk2?	No
	X Walk 1 Direction	To SE		X Walk 2 Direction	To NE
N/A	X Walk 1 Width (in)	N/A	N/A	X Walk 2 Width (in)	N/A
	X Walk 1 Slope (%)	0.7		X Walk 2 Slope (%)	4.7
	X Walk 1 X Slope (%)	4.1		X Walk 2 X Slope (%)	2.3

N/A	Ramp inside XWalk1?	N/A	N/A	Ramp inside XWalk2?	N/A
	Road Slope (%)	2.5	N/A	Clear Space?	N/A
	Road X Slope (%)	7.6	N/A	Clear Space to XWalk (in)	N/A
N/A	Any Obstructions?	N/A	N/A	Storm Grate/Utility Hazard?	N/A
	Obstruction Type			Storm Grate/Utility Type	
		N/A			N/A
			Yes	Surface Condition? (G/P)	Good

Remove & Replace Curb Ramp With Two New Directional Ramps or Equivalent.
