# Access Compliance Report

## Public Rights-of-Way (Curb Ramps)

| Intersection ID: 10040584 | | Main Street: W_ARROWWOOD_RD | | Cross Street: N/A | | Location: | | SW | |
| ADA ID: 5321F5F1864D | | Ramp Type: Directional1 | | Initial Pass/Fail: Pass | | Overall Compliance: No | | Severity Score: 2.5 | |

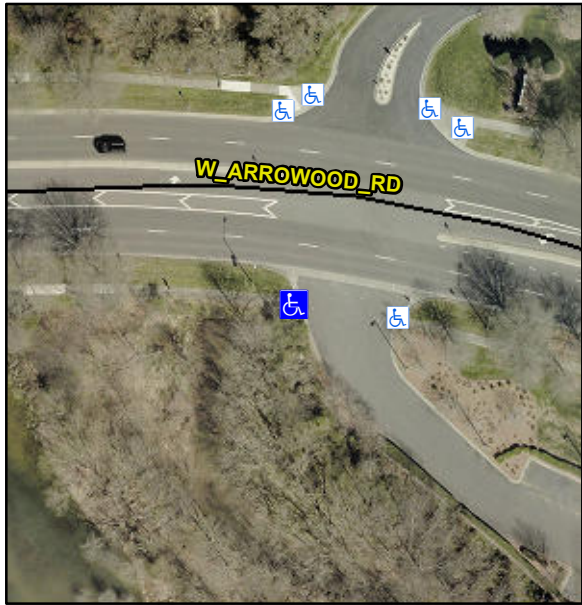
| | | | | No | Landing Slope (%) | 3.6 | Yes | DWS Length (in) | 24.0 |
| | | | | Yes | Landing X Slope (%) | 1.2 | No | DWS Full Width? | No |
| | | | | Yes | Gutter Lip Ht (in) | 0.0 | No | Gutter X Slope (%) | 2.2 |

| <div></div> <div>Possible Solutions:<br/><br/><b>Remove &amp; Replace Entire Ramp.<br/>Remove &amp; Replace Gutter.</b></div> <div>Surveyor Notes:<br/><br/><b>N/A</b></div> <div>PROW/ADA:<br/><br/><b>Not Found, R304.2.2-Perp, R304.3.2-Para, R304.5.2, R305.1.4, R304.5.3</b></div> <div><div>Street 1 NameENTRANCE</div><div>Stop Condition-Street 1StopSign</div><div>Street 2 NameN/A</div><div>Stop Condition-Street 2N/A</div></div> <div>Total Cost:\$2350.00</div> | | | | Compliance | Description | Data | Compliance | Description | Data |
