# Access Compliance Report

## Public Rights-of-Way

### (Curb Ramps)

| Intersection ID: 52521 | Main Street: LORNA_ST | Cross Street: MCCLINTOCK_RD | Location: SE |

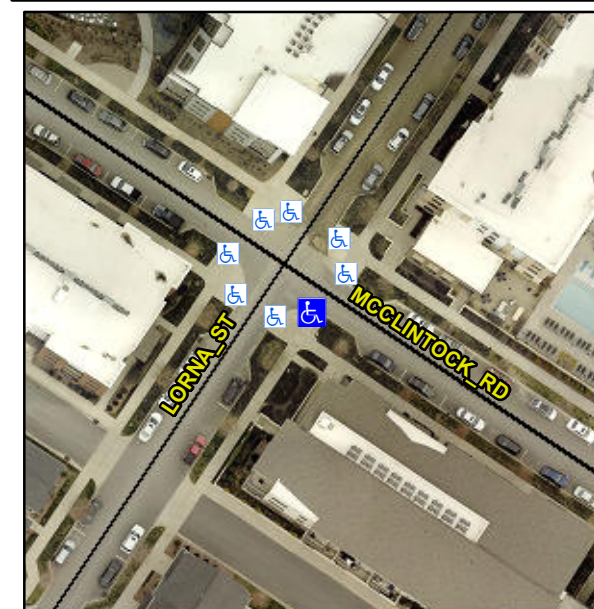
| ADA ID: 53221797FB58 | Ramp Type: BlendTrans1 | Initial Pass/Fail: Pass | Overall Compliance: No |
| Severity Score: 0.25 | | | |

**R304.5.3, R304.2.2-Perp, R304.3.2-Para, R305.2**

| Compliance | Description | Data | Compliance | Description | Data |
|---|---|---|---|---|---|
| Yes | Ramp Width (in) | 72.0 | No | BlendTrans XSlope (%) | 2.3 |
| No | Landing Slope (%) | 3.9 | Yes | DWS Length (in) | 24.0 |
| No | Landing X Slope (%) | 2.3 | Yes | DWS Full Width? | Yes |
| N/A | Landing Curb? (Y/N) | No | No | DWS Offset (in) | 5.5 |

**Remove & Replace Curb Ramp With Two New Directional Ramps or Equivalent.**

Total Cost: \$ 3200.00
