Access Compliance Report

Public Rights-of-Way

(Curb Ramps)

Intersection ID: 18253	Main Street: APPLE_PIE_CT	Cross Street: LITTLE_MOSER_LN	Location: NW
ADA ID: 53279EBAC73C	Ramp Type: PerpDiag	Initial Pass/Fail: Fail	Overall Compliance: No
			Severity Score: 31.25

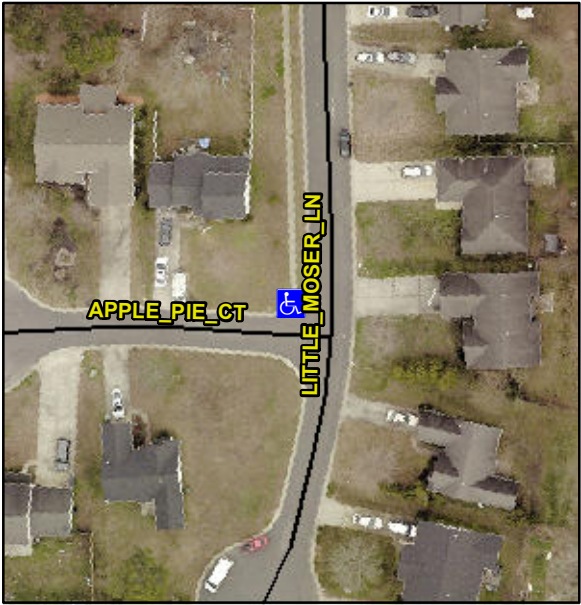
Possible Solutions:		Compliance	Description	Data
	Remove & Replace Curb Ramp With Two New Directional Ramps or Equivalent.		No	Ramp Length (in)	51.0
			No	Ramp Width (in)	35.0
			N/A	Flare Type LT	N/A
			N/A	Flare Slope LT (%)	N/A
			N/A	Flare Traversable LT?	N/A
			N/A	Landing Length (in)	N/A
			N/A	Landing Width (in)	N/A
			N/A	Landing Slope (%)	N/A
			N/A	Landing X Slope (%)	N/A
<p>Surveyor Notes:</p> <p>N/A</p> <p>PROW/ADA:</p> <p>Not Found, R304.5.1, R304.2.2, R304.5.3</p>			N/A	Flare Type RT	N/A
			N/A	Flare Slope RT (%)	N/A
			N/A	Flare Traversable RT?	N/A
			N/A	DWS Provided?	N/A
			N/A	DWS Contrast?	N/A
			N/A	DWS Length (in)	N/A
			N/A	DWS Full Width?	N/A
			N/A	DWS Offset (in)	N/A
			N/A	Gutter Ponding?	N/A
			N/A	Gutter Lip Ht (in)	N/A
<p>Total Cost:</p> <p>\$ 3200.00</p>			No	Painted X Walk1?	No
				X Walk 1 Direction	To SW

N/A	X Walk 1 Width (in)	N/A
				X Walk 1 Slope (%)	3.8
				X Walk 1 X Slope (%)	4.6
			N/A	Ramp inside XWalk1?	N/A
				Road Slope (%)	1.8
				Road X Slope (%)	2.9
			N/A	Any Obstructions?	N/A
				Obstruction Type	
			N/A	Clear Space?	N/A
			N/A	Clear Space to XWalk (in)	N/A
			N/A	Storm Grate/Utility Hazard?	N/A
				Storm Grate/Utility Type	
			N/A		N/A
			Yes	Surface Condition? (G/P)	Good
