Access Compliance Report

Public Rights-of-Way (Curb Ramps)

Intersection ID: 46685	Main Street: JEWELFLOWER_RD	Cross Street: GOLDFIELDS_DR	Location: NE
ADA ID: 532ED55159CA	Ramp Type: PerpDiag	Initial Pass/Fail: Fail	Overall Compliance: No
Severity Score: 12.5			
Codes/Mitigation Info/Possible Solution		Field Measurements/Component Compliance

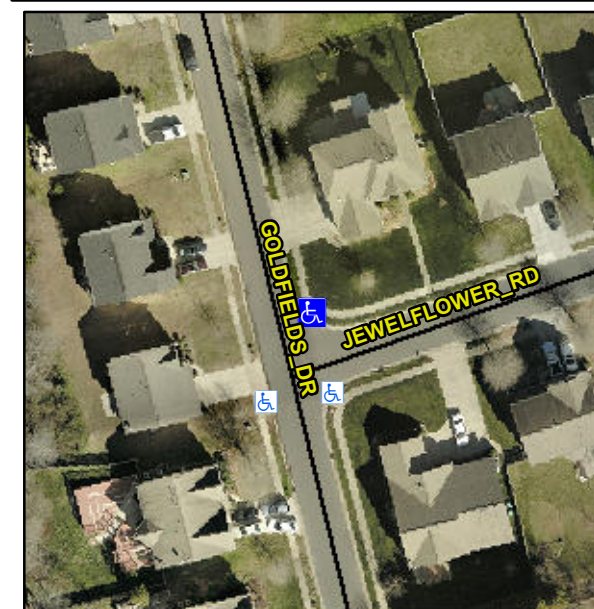
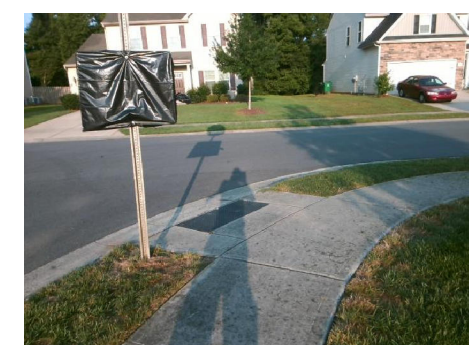
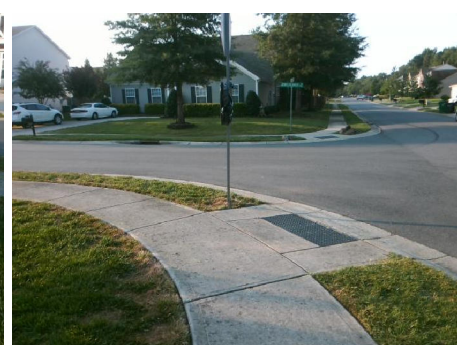
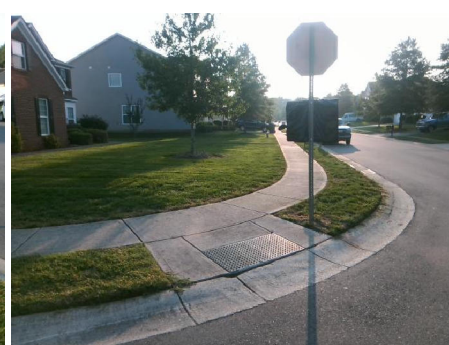
Not Found, R304.2.2

Compliance	Description	Data	Compliance	Description	Data
N/A	Ramp Length (in)	95.0	No	Ramp Slope (%)	8.9
Yes	Ramp Width (in)	48.0	Yes	Ramp XSlope (%)	0.5
N/A	Flare Type LT	N/A	N/A	Flare Type RT	N/A
N/A	Flare Slope LT (%)	N/A	N/A	Flare Slope RT (%)	N/A
N/A	Flare Traversable LT?	N/A	N/A	Flare Traversable RT?	N/A
N/A	Landing Length (in)	N/A	N/A	DWS Provided?	N/A
N/A	Landing Width (in)	N/A	N/A	DWS Contrast?	N/A
N/A	Landing Slope (%)	N/A	N/A	DWS Length (in)	N/A
N/A	Landing X Slope (%)	N/A	N/A	DWS Full Width?	N/A
N/A	Landing Curb? (Y/N)	N/A	N/A	DWS Offset (in)	N/A
N/A	Shared Landing?	N/A			
N/A	Gutter Ponding?	N/A	N/A	Gutter Slope (%)	N/A
N/A	Gutter Lip Ht (in)	N/A	N/A	Gutter X Slope (%)	N/A
N/A	Painted X Walk1?	No	N/A	Painted X Walk2?	No
	X Walk 1 Direction	To W		X Walk 2 Direction	To S
N/A	X Walk 1 Width (in)	N/A	N/A	X Walk 2 Width (in)	N/A
	X Walk 1 Slope (%)	0.9		X Walk 2 Slope (%)	1.7
	X Walk 1 X Slope (%)	2.0		X Walk 2 X Slope (%)	0.5

N/A	Ramp inside XWalk1?	N/A	N/A	Ramp inside XWalk2?	N/A
	Road Slope (%)	0.8	N/A	Clear Space?	N/A
	Road X Slope (%)	3.2	N/A	Clear Space to XWalk (in)	N/A
N/A	Any Obstructions?	N/A	N/A	Storm Grate/Utility Hazard?	N/A
	Obstruction Type			Storm Grate/Utility Type	
		N/A			N/A
			Yes	Surface Condition? (G/P)	Good

Remove & Replace Curb Ramp With Two New Directional Ramps or Equivalent.
