Intersection ID: 6285	Main Street: ALLEN_RD_EAST	Cross Street: EARGLE_RD	Location:	SW
ADA ID: 5333BC3A6B4F	Ramp Type: Perp	Initial Pass/Fail: Fail	Overall Compliance: No	Severity Score: 25

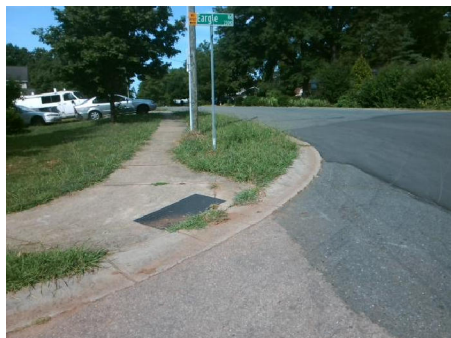
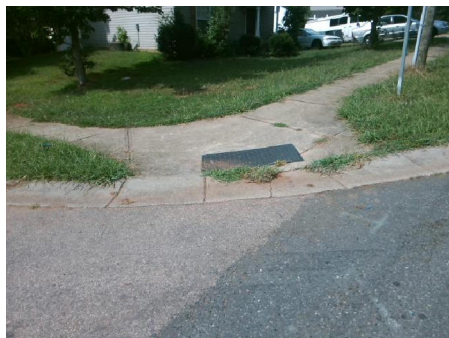
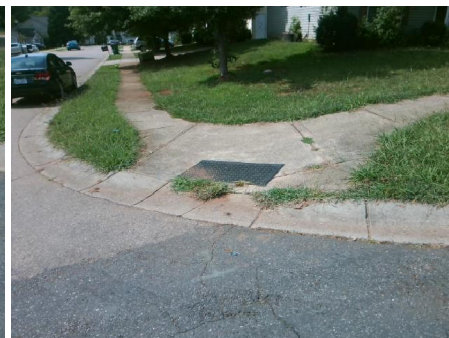
Compliance	Description	Data	Compliance	Description	Data
N/A	Ramp Length (in)	60.0	Yes	Ramp Slope (%)	7.7
Yes	Ramp Width (in)	51.0	No	Ramp XSlope (%)	13.4
N/A	Flare Type LT	N/A	N/A	Flare Type RT	N/A
N/A	Flare Slope LT (%)	N/A	N/A	Flare Slope RT (%)	N/A
N/A	Flare Traversable LT?	N/A	N/A	Flare Traversable RT?	N/A
N/A	Landing Length (in)	N/A	N/A	DWS Provided?	N/A
N/A	Landing Width (in)	N/A	N/A	DWS Contrast?	N/A
N/A	Landing Slope (%)	N/A	N/A	DWS Length (in)	N/A
N/A	Landing X Slope (%)	N/A	N/A	DWS Full Width?	N/A
N/A	Landing Curb? (Y/N)	N/A	N/A	DWS Offset (in)	N/A
N/A	Shared Landing?	N/A			
N/A	Gutter Ponding?	N/A	N/A	Gutter Slope (%)	N/A
N/A	Gutter Lip Ht (in)	N/A	N/A	Gutter X Slope (%)	N/A
N/A	Painted X Walk1?	No	N/A	Painted X Walk2?	N/A
	X Walk 1 Direction	To E		X Walk 2 Direction	N/A
N/A	X Walk 1 Width (in)	N/A	N/A	X Walk 2 Width (in)	N/A
	X Walk 1 Slope (%)	1.7		X Walk 2 Slope (%)	N/A
	X Walk 1 X Slope (%)	1.7		X Walk 2 X Slope (%)	N/A

N/A	Ramp inside XWalk1?	N/A	N/A	Ramp inside XWalk2?	N/A
	Road Slope (%)	N/A	N/A	Clear Space?	N/A
	Road X Slope (%)	N/A	N/A	Clear Space to XWalk (in)	N/A
N/A	Any Obstructions?	N/A	N/A	Storm Grate/Utility Hazard?	N/A
	Obstruction Type			Storm Grate/Utility Type	
		N/A			N/A
			Yes	Surface Condition? (G/P)	Good

Remove & Replace Entire Ramp.
