# Access Compliance Report

## Public Rights-of-Way

### (Curb Ramps)

| Intersection ID: 11566 | Main Street: GRANDIN_RD | Cross Street: LITAKER_AV | Location: NW |

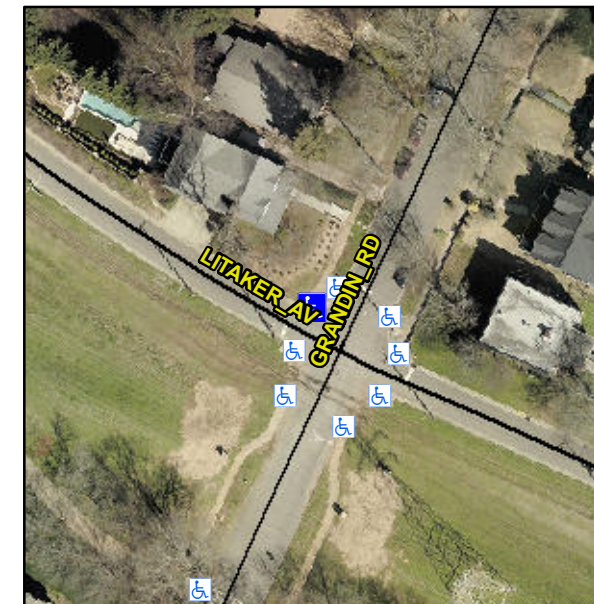
**Not Found, R304.2.2**

| Compliance | Description | Data | Compliance | Description | Data |
|---|---|---|---|---|---|
| N/A | Ramp Length (in) | 75.0 | No | Ramp Slope (%) | 9.1 |

**Remove & Replace Entire Ramp.**

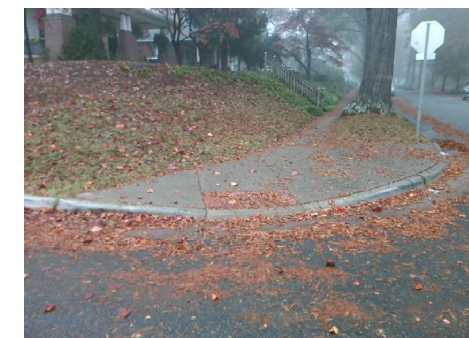
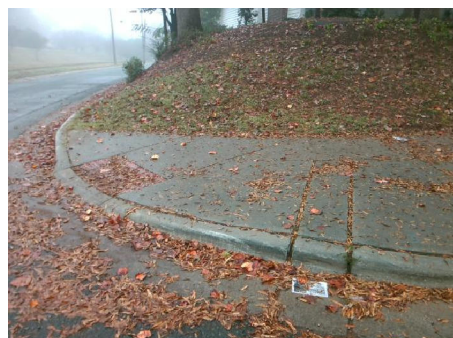
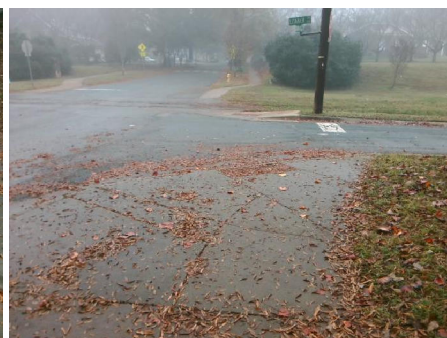
| Compliance | Description | Data | Compliance | Description | Data |
|---|---|---|---|---|---|
| Yes | Ramp Width (in) | 48.0 | Yes | Ramp XSlope (%) | 0.8 |
| | | | Yes | Surface Condition? (G/P) | Good |
