Access Compliance Report

Public Rights-of-Way

(Curb Ramps)

Intersection ID: 48999	Main Street: STEELECROFT_FARM_LN	Cross Street: STEELECROFT_PY	Location: NE
ADA ID: 53342305E9A7	Ramp Type: Perp	Initial Pass/Fail: Pass	Overall Compliance: No
		Severity Score: 0.25

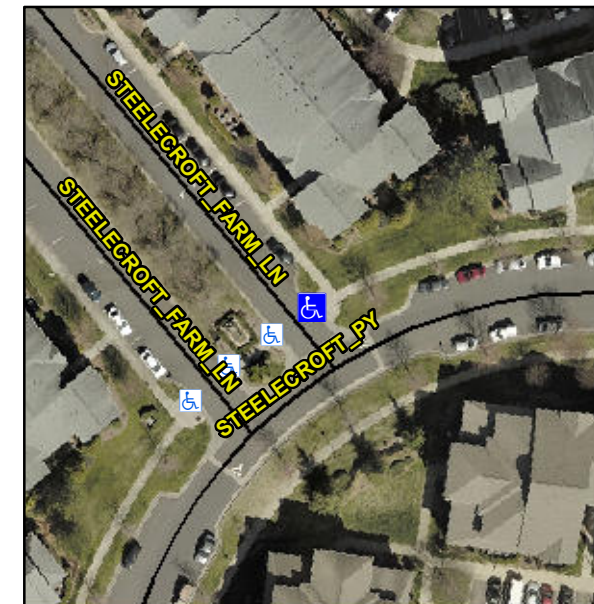
Not Found, R304.5.3, R304.2.2-Perp, R304.3.2-Para

Compliance	Description	Data	Compliance	Description	Data
N/A	Ramp Length (in)	95.0	Yes	Ramp Slope (%)	6.4
Yes	Ramp Width (in)	48.0	No	Ramp XSlope (%)	3.0
N/A	Flare Type LT	Sloped	N/A	Flare Type RT	N/A
N/A	Flare Slope LT (%)	6.0	N/A	Flare Slope RT (%)	6.3
N/A	Flare Traversable LT?	No	N/A	Flare Traversable RT?	No
Yes	Landing Length (in)	59.0	Yes	DWS Provided?	Yes
Yes	Landing Width (in)	48.0	Yes	DWS Contrast?	Yes
No	Landing Slope (%)	2.1	Yes	DWS Length (in)	24.0
Yes	Landing X Slope (%)	2.6	Yes	DWS Full Width?	Yes
N/A	Landing Curb? (Y/N)	No	Yes	DWS Offset (in)	0.0
N/A	Shared Landing?	No			
Yes	Gutter Ponding?	No	Yes	Gutter Slope (%)	1.1
Yes	Gutter Lip Ht (in)	0.0	Yes	Gutter X Slope (%)	2.4
N/A	Painted X Walk1?	No	N/A	Painted X Walk2?	N/A
	X Walk 1 Direction	To SW		X Walk 2 Direction	N/A
N/A	X Walk 1 Width (in)	N/A	N/A	X Walk 2 Width (in)	N/A
	X Walk 1 Slope (%)	1.0		X Walk 2 Slope (%)	N/A
	X Walk 1 X Slope (%)	2.9		X Walk 2 X Slope (%)	N/A

N/A	Ramp inside XWalk1?	N/A	N/A	Ramp inside XWalk2?	N/A
	Road Slope (%)	N/A	N/A	Clear Space?	Yes
	Road X Slope (%)	N/A	N/A	Clear Space to XWalk (in)	N/A
Yes	Any Obstructions?	No	Yes	Storm Grate/Utility Hazard?	No
	Obstruction Type			Storm Grate/Utility Type	
		N/A			N/A
			Yes	Surface Condition? (G/P)	Good

Remove & Replace Entire Ramp.
