# Access Compliance Report

## Public Rights-of-Way

### (Curb Ramps)

Intersection ID: 13708	Main Street: WEST_BV	Cross Street: WICKFORD_PL	Location: SW
ADA ID: 5349A3964A81	Ramp Type: BlendTrans2	Initial Pass/Fail: Fail	Overall Compliance: No
		Severity Score: 1.25

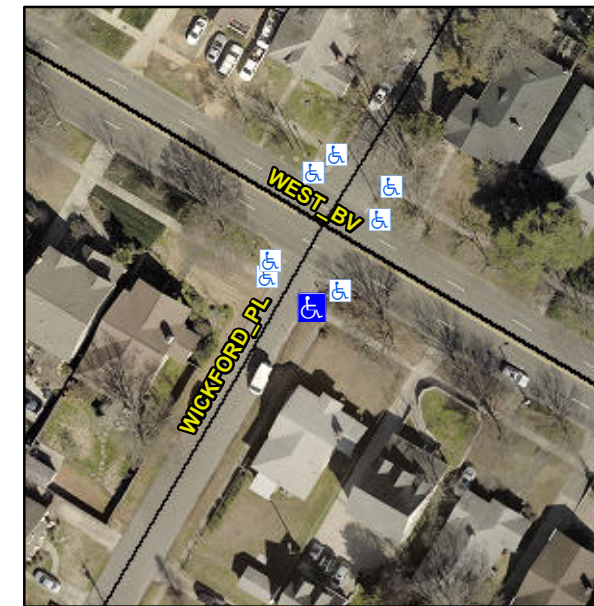
**Not Found, R304.5.3**

Compliance	Description	Data	Compliance	Description	Data
N/A	Ramp Length (in)	80.0	Yes	BlendTrans Slope (%)	1.5
Yes	Ramp Width (in)	61.0	No	BlendTrans XSlope (%)	2.8
N/A	Flare Type LT	N/A	N/A	Flare Type RT	N/A
N/A	Flare Slope LT (%)	N/A	N/A	Flare Slope RT (%)	N/A
N/A	Flare Traversable LT?	N/A	N/A	Flare Traversable RT?	N/A
N/A	Landing Length (in)	N/A	N/A	DWS Provided?	N/A
N/A	Landing Width (in)	N/A	N/A	DWS Contrast?	N/A
N/A	Landing Slope (%)	N/A	N/A	DWS Length (in)	N/A
N/A	Landing X Slope (%)	N/A	N/A	DWS Full Width?	N/A
N/A	Landing Curb? (Y/N)	N/A	N/A	DWS Offset (in)	N/A
N/A	Shared Landing?	N/A			
N/A	Gutter Ponding?	N/A	N/A	Gutter Slope (%)	N/A
N/A	Gutter Lip Ht (in)	N/A	N/A	Gutter X Slope (%)	N/A
N/A	Painted X Walk1?	No	N/A	Painted X Walk2?	N/A
	X Walk 1 Direction	To NW		X Walk 2 Direction	N/A
	X Walk 1 Width (in)	N/A		X Walk 2 Width (in)	N/A
	X Walk 1 Slope (%)	0.8		X Walk 2 Slope (%)	N/A
	X Walk 1 X Slope (%)	1.6		X Walk 2 X Slope (%)	N/A

N/A	Ramp inside XWalk1?	N/A	N/A	Ramp inside XWalk2?	N/A
	Road Slope (%)	1.6		Clear Space?	N/A
	Road X Slope (%)	0.8	N/A	Clear Space to XWalk (in)	N/A
N/A	Any Obstructions?	N/A	N/A	Storm Grate/Utility Hazard?	N/A
	Obstruction Type			Storm Grate/Utility Type	
		N/A			N/A
			Yes	Surface Condition? (G/P)	Good
			No	Curb Slope (%)	19.1

**Remove & Replace Curb Ramp With Two New Directional Ramps or Equivalent.**

Total Cost: \$ 3200.00
