Intersection ID: 12205	Main Street: S_MINT_ST	Cross Street: W_3RD_ST	Location:	W
ADA ID: 534B055DC52F	Ramp Type: Perp	Initial Pass/Fail: Fail	Overall Compliance: No	Severity Score: 21.25

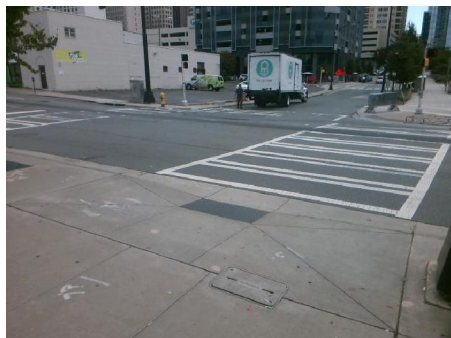
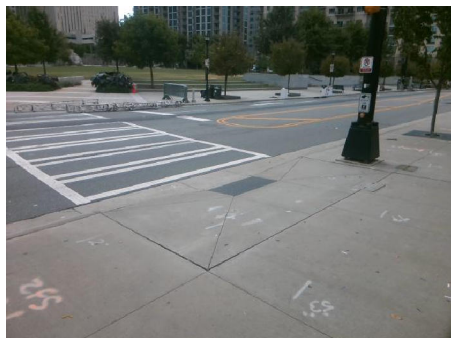
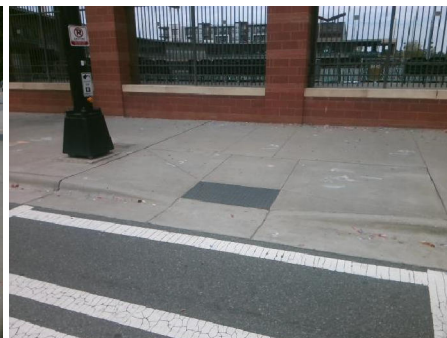
**Not Found, R304.5.1, R304.2.2**

Compliance	Description	Data	Compliance	Description	Data
N/A	Ramp Length (in)	78.0	No	Ramp Slope (%)	8.8
No	Ramp Width (in)	47.5	Yes	Ramp XSlope (%)	0.9
N/A	Flare Type LT	N/A	N/A	Flare Type RT	N/A
N/A	Flare Slope LT (%)	N/A	N/A	Flare Slope RT (%)	N/A
N/A	Flare Traversable LT?	N/A	N/A	Flare Traversable RT?	N/A
N/A	Landing Length (in)	N/A	N/A	DWS Provided?	N/A
N/A	Landing Width (in)	N/A	N/A	DWS Contrast?	N/A
N/A	Landing Slope (%)	N/A	N/A	DWS Length (in)	N/A
N/A	Landing X Slope (%)	N/A	N/A	DWS Full Width?	N/A
N/A	Landing Curb? (Y/N)	N/A	N/A	DWS Offset (in)	N/A
N/A	Shared Landing?	N/A			
N/A	Gutter Ponding?	N/A	N/A	Gutter Slope (%)	N/A
N/A	Gutter Lip Ht (in)	N/A	N/A	Gutter X Slope (%)	N/A
N/A	Painted X Walk1?	Yes	N/A	Painted X Walk2?	N/A
	X Walk 1 Direction	To SE		X Walk 2 Direction	N/A
N/A	X Walk 1 Width (in)	171.0	N/A	X Walk 2 Width (in)	N/A
	X Walk 1 Slope (%)	1.8		X Walk 2 Slope (%)	N/A
	X Walk 1 X Slope (%)	0.8		X Walk 2 X Slope (%)	N/A

N/A	Ramp inside XWalk1?	Yes	N/A	Ramp inside XWalk2?	N/A
	Road Slope (%)	N/A	N/A	Clear Space?	N/A
	Road X Slope (%)	N/A	N/A	Clear Space to XWalk (in)	N/A
N/A	Any Obstructions?	N/A	N/A	Storm Grate/Utility Hazard?	N/A
	Obstruction Type			Storm Grate/Utility Type	
		N/A			N/A
			Yes	Surface Condition? (G/P)	Good

### Remove & Replace Entire Ramp.
